# Rock Failure Assessment on Paleo-Collapse in Case of the Prasat Hin Pan Yod tourist site, Satun Geopark, Thailand

*Environmental Geology Division, Department of Mineral Resources (DMR), Bangkok, Thailand*

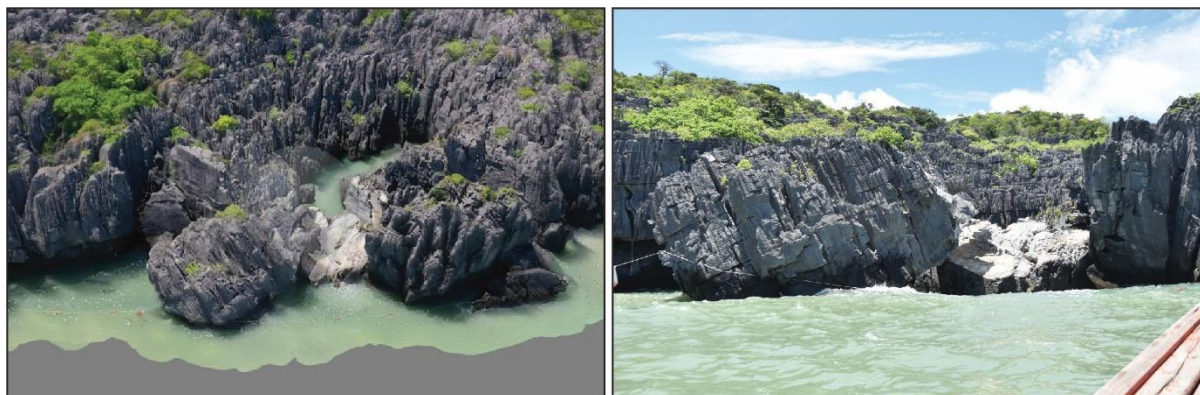
**Fig. 1:** The latest rockslide big event happened in the north part of the Prasat Hin Pan Yod chamber, Khao Yai Island on February 20, 2021

Based on the DMR field evidence, the rockslide occurrence may briefly conclude in four parts. First: erosion of fractured and cavernous limestone by sea, due to the location placing at the narrow strait of Khao Yai Island and the other island on the northern side, strong waves and rapid currents can enter cave passages to hit unstable rock columns that partly support cave roof, because of hydraulic power of the waves and compression of air within a confined space provide the fissures in rock mass widen and deepen and lead to having a broken column. Second: as a result of the supporting column is being broken, the loss of rock strengths cannot carry limestone overburden at the upper part. Third: the massive limestone volumes suddenly separated from the weakened sea cliff along major linear faults. Fourth: the upper part slides through rock mass sub-parallel bedding plane / along low angle fault and falls in the north direction into the sea, hiding the traditional entrance of the chamber. The fragment block of the rock-

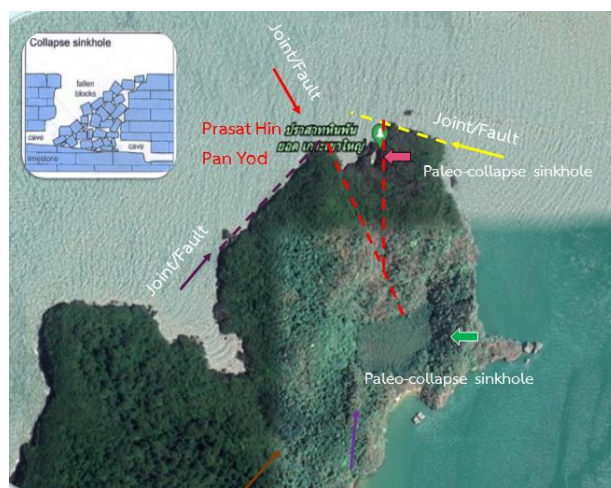
**Fig.2:** the Prasat Hin Pan Yod chamber showing oval shaped collapse sinkhole that occurred next to an older rectangular shape (Blue arrow)

-slide location is not far from the precedent rock topple. As mentioned above, the paleo-collapse sinkhole at the Prasat Hin Pan Yod can be a recurrence, particularly on the edge of the chamber.

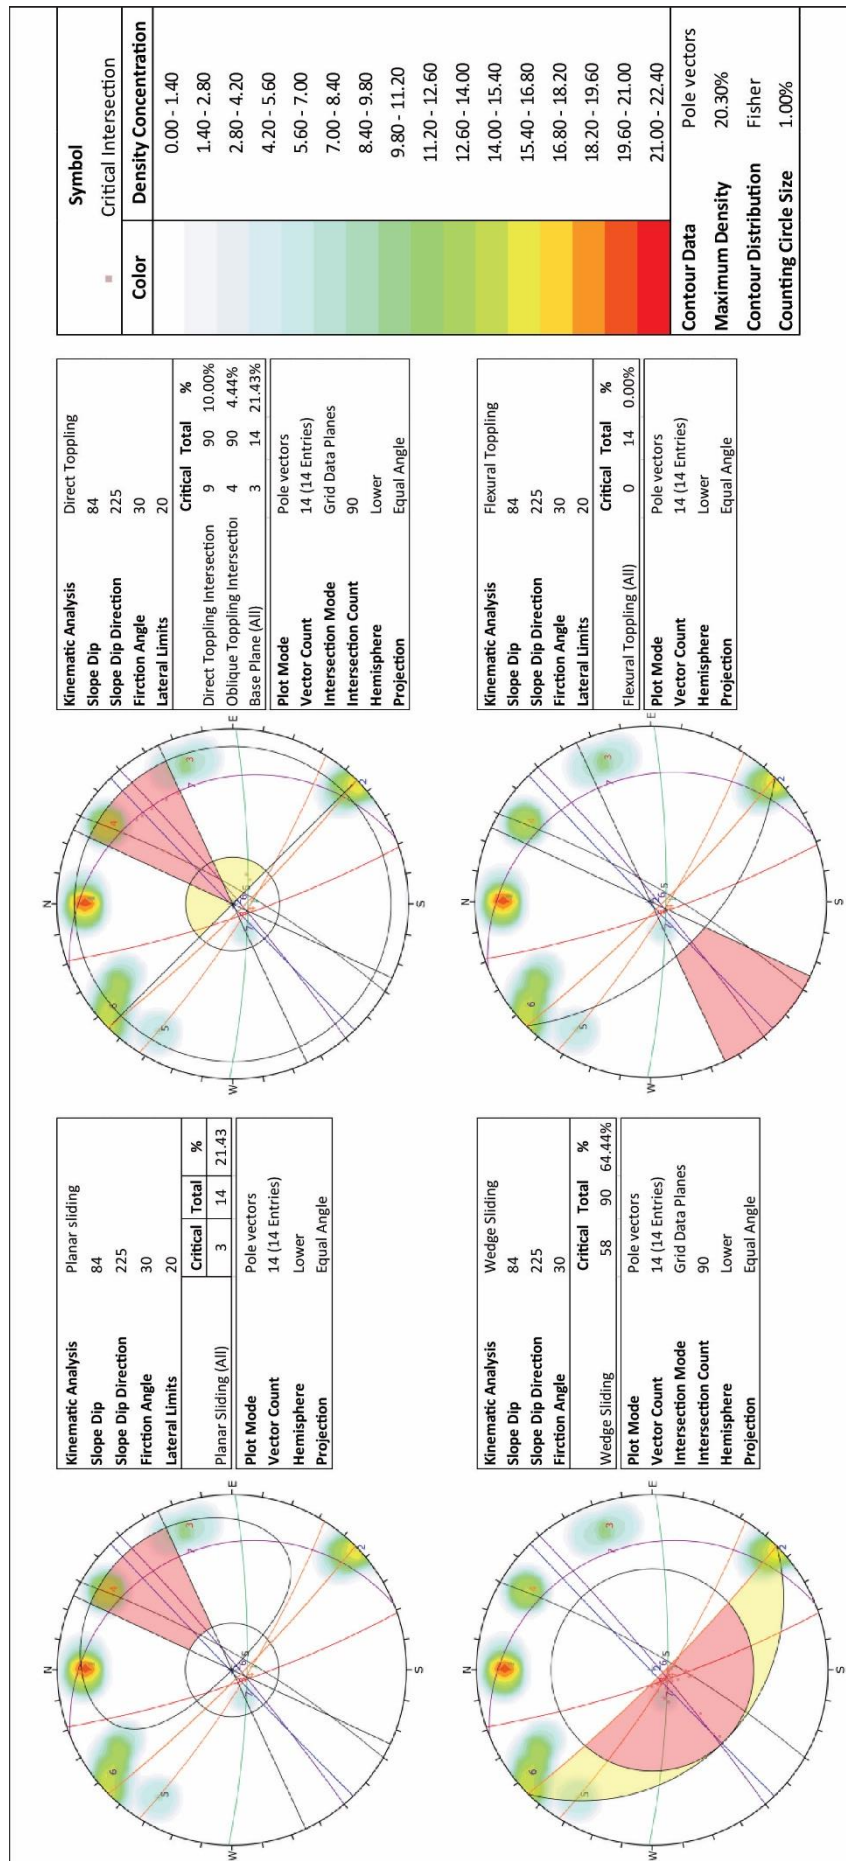
Fig. 8: showing stereographic projection of the station 2C

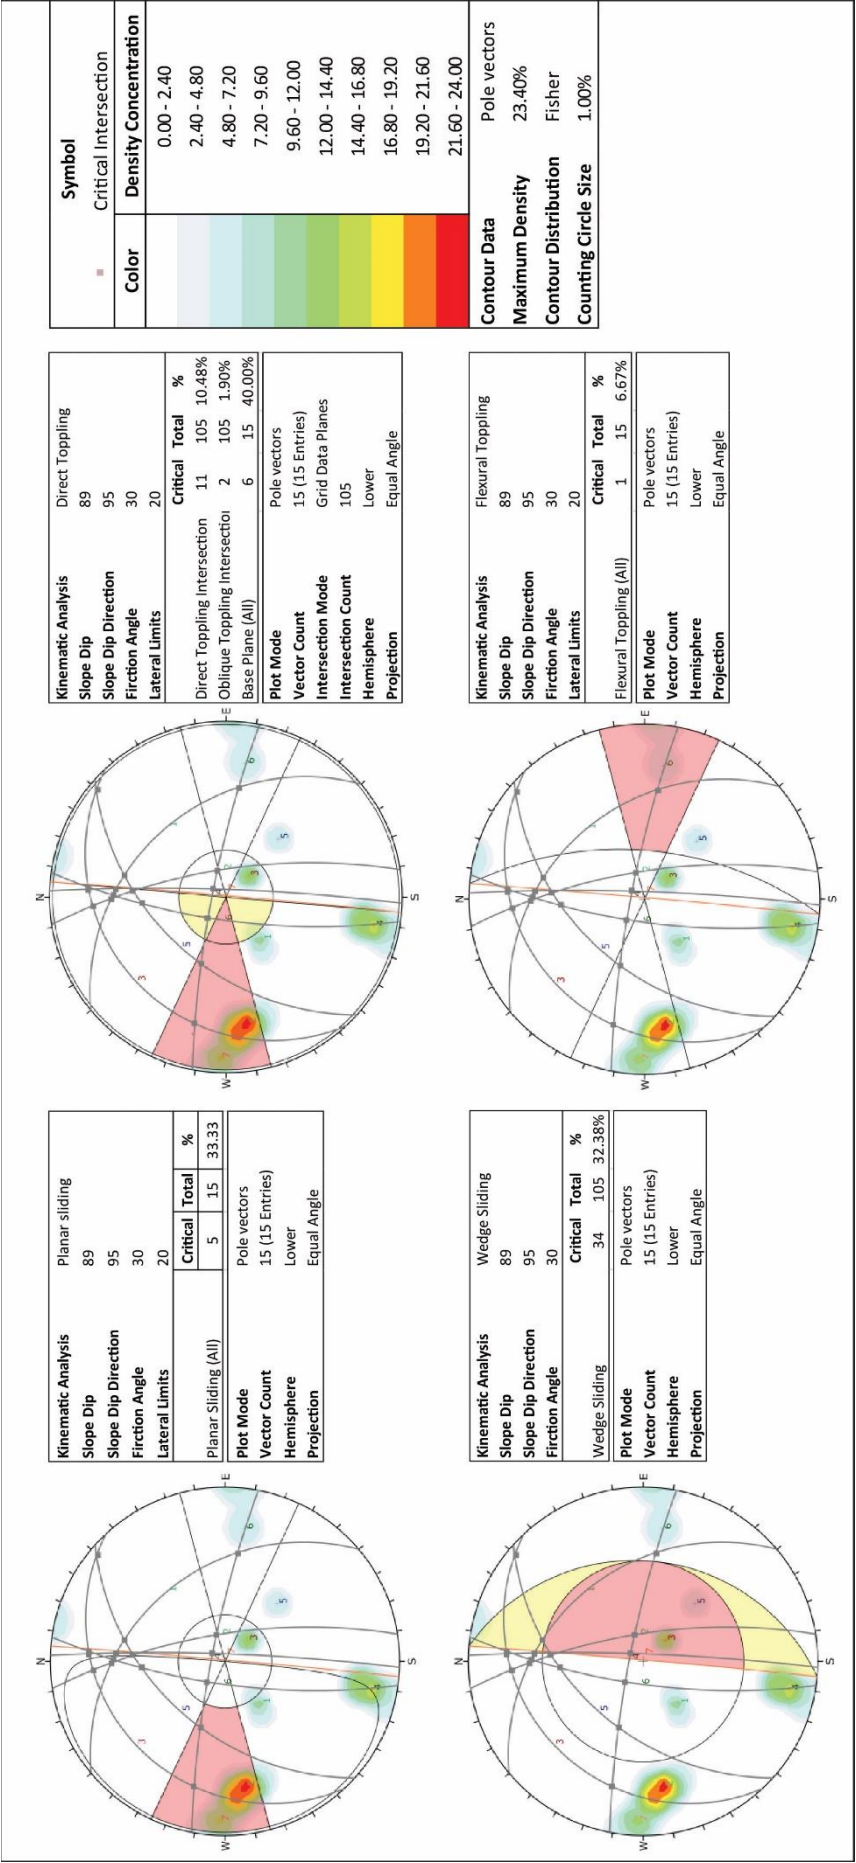
Fig.9: showing stereographic projection of the station 3B

Station 3A-3D is the lower part of the broken rock that remained from the rockslide event in February 2021. The SMR value was range 18-69 (Table 5), and it was almost categorized as a good class and normal class. The SMR value of direct toppling failure was partly categorized as very bad (two values) to bad (one value), meanwhile, four SMR value

of wedge failure was classified as a bad class. The very bad to bad SMR class of direct toppling failure had a joint plan dipping to the east. The bad SMR class of wedge failure had five intersects of joint sets plunging to the northwest and nearly north (Table 6) and it maybe caused by wedge failure of rockfall type. Although the SMR value of planar failure is classified as a normal class, the rockslide can be occurred as well particularly, in the case of repeatedly column supporting broken. For safety, the tourist route should not pass station 3A-3D getting through the Prasat Hin Pan Yod chamber.

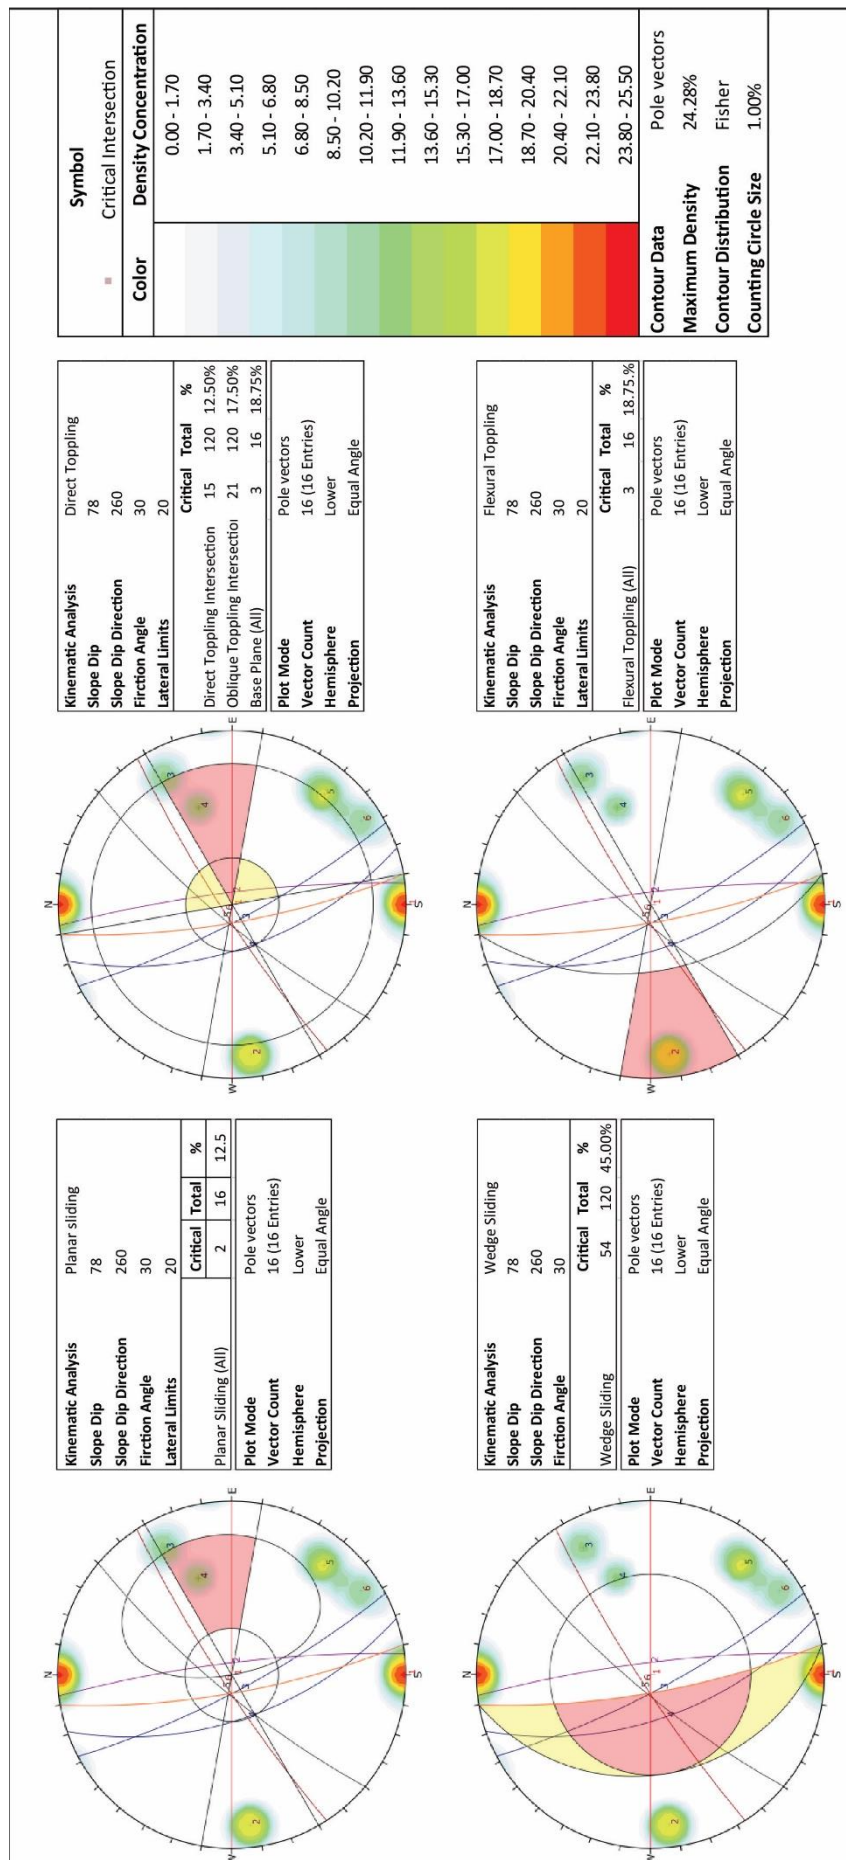
Fig. 10: showing stereographic projection of the station 4A

joint sets plunges to the west and southwest which shows potential wedge failure of rockfall hazard type (Table 6). Tourists may be slightly affected by small pieces of rock wedge that pending at high places. Fortunately, distance passing station 4A and getting through is quite short (not over 3 meters).

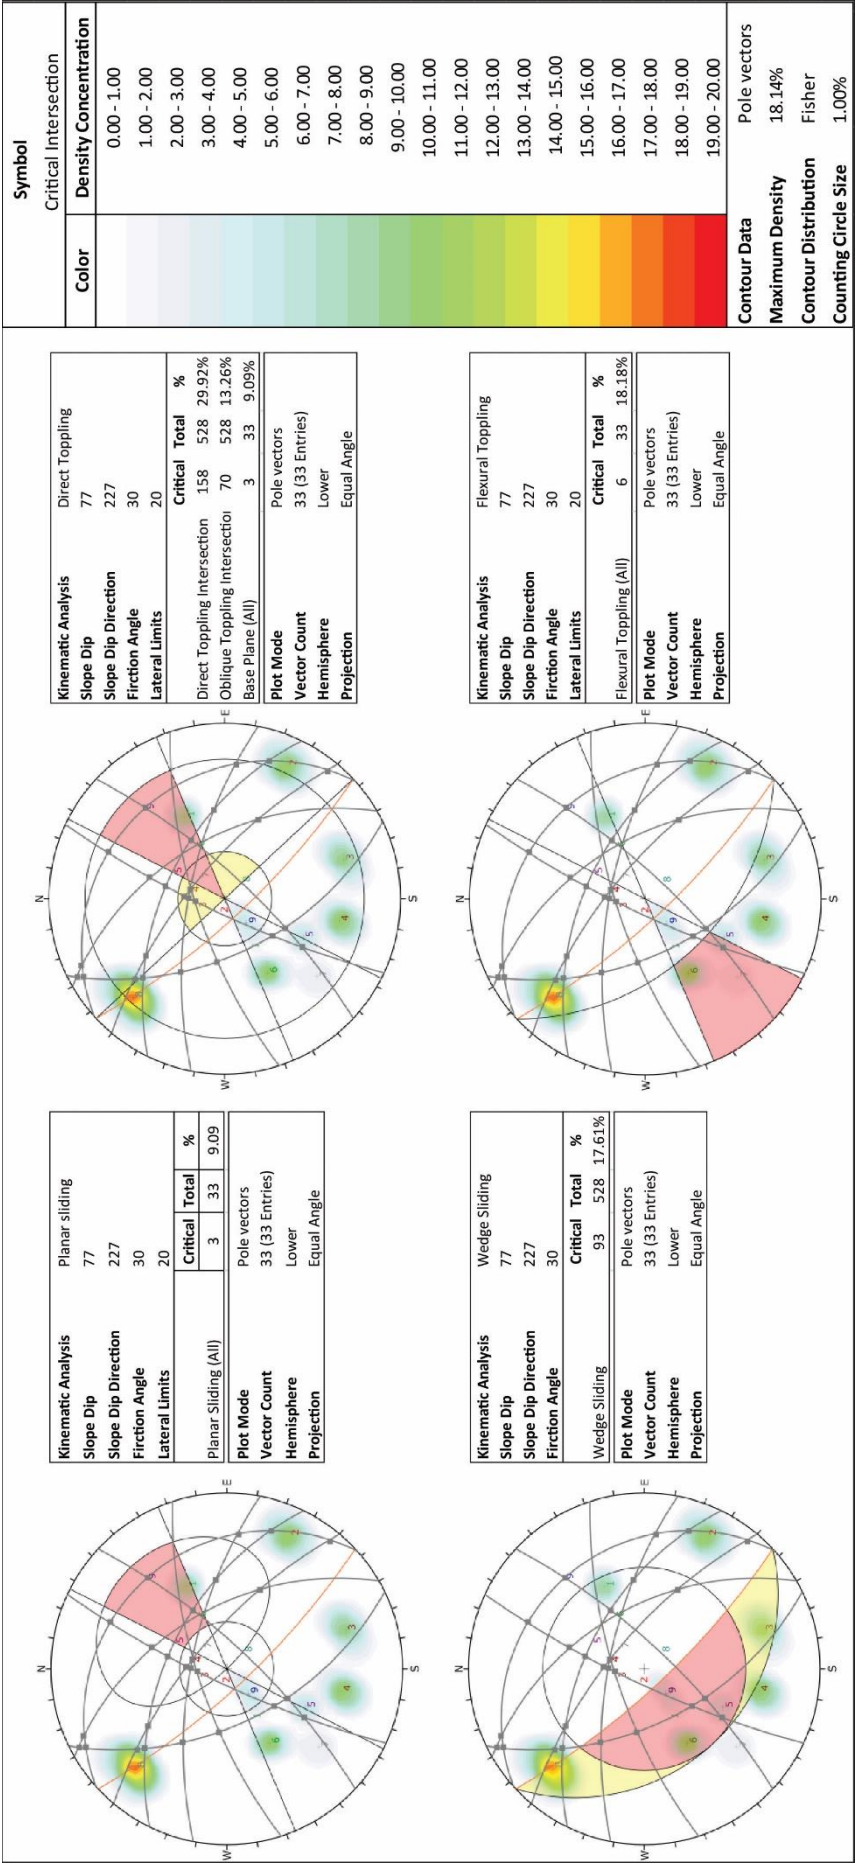
Fig. 11: showing stereographic projection of the station 7D

Station 7A to 7F is the huge block of planar rockslide that occurred by column supporting broken in the event of February 2021. The investigated stations had SMR values of 19-70 (Table 5 and Table 6), which were classified as very bad to good. The dominant SMR values were categorized as a good class. Two intersections of joint sets of wedge failure had SMR value of 19, which were categorized as a very bad class. There were five intersections of joint sets of wedge failure, which were classified as a bad class (28-34.3).

Furthermore, four intersections of joint sets of wedge failure and one joint plan of direct toppling were classified as a normal class, which still had partially stable. The rock movement direction was mainly plunging west to northwest (W-NW) and southeast to southwest (SE-SW) (Table 6). As mentioned,

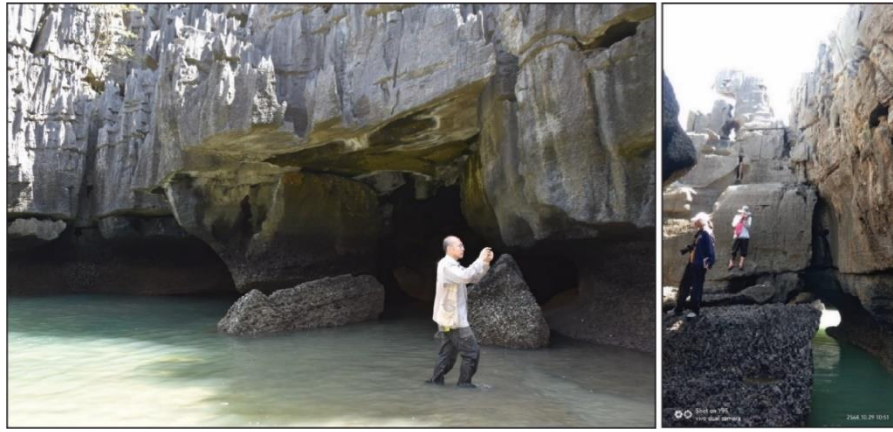
Station 2A (Fig. 13) is a place of the sea cave that locating beneath a massive limestone roof and supported by a thin column. The evidence of a former rockfall had two big blocks. Due to the high energy of currents and waves, rock collapse might have occurred in nearly future. The SMR value's wedge failure (Table 3 and 5) was categorized as bad and very bad. The SMR value was 8-18 and 25.5-33, respectively. Wedge failure of rockfall type has a higher potential to have occurred than planar and toppling failure. Moreover, bedding rockfall blocks is one of the high potential hazards, and it is difficult to determine by the SMR approach.

**Fig. 13:** photograph of station 2A (right) and station 4A (left)

The line of stations 4A and 6A to 6C are said to be the safest new route to getting through the chamber. However, the wedge failure of rockfall can occur within a short distance of a sea cliff (about 3 meters). A helmet, one of the simple tools, can protect tourists from fallen rock which it is pending on sea cliffs or high places. For the linear strait, the route is narrow, and slightly strong waves in some time, kayak carrying tourists passing should be controlled and permit a one for in and out.
