Debris Flow in Peninsular Malaysia - Case Study on Sungai Kupang Debris Flow, Kedah

Department of Mineral and Geoscience Malaysia

Abstract

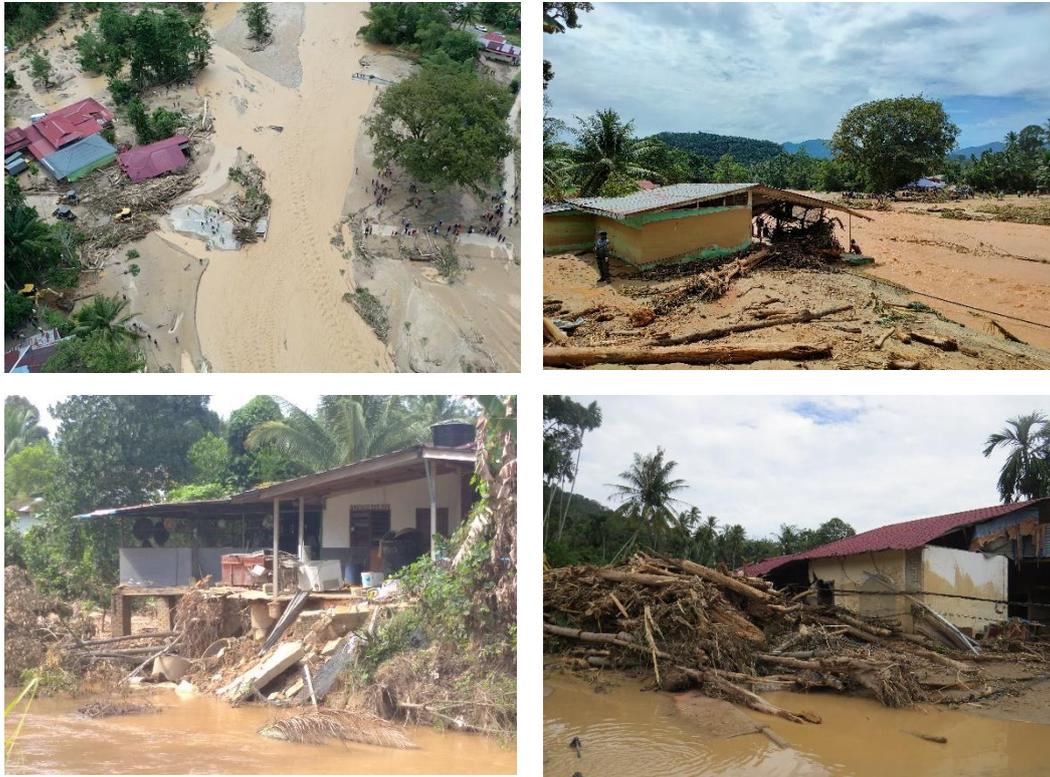
Kampung Iboi, a Malay traditional village and several villages downstream which are located on the banks of Sungai Kupang, Baling, Kedah were hit by the debris and mud flood on 04 July 2022. The disaster claimed 3 people, destroyed 17 houses and affected 3,546 with losses estimated at RM 25.91 million. The disaster with a high destructive power is the main cause of death and destruction of many infrastructure (Fig. 1). This incident happened very quickly, starting around 4 pm and the flood receded only after the next few hours. The debris flow and flood in Kampung Iboi was caused by a combination of several geological processes in the upstream area of Sungai Kupang. Heavy rains have triggered

Fig. 1: Photo of Kampung Iboi, Sungai Kupang, Kedah (the most affected area)

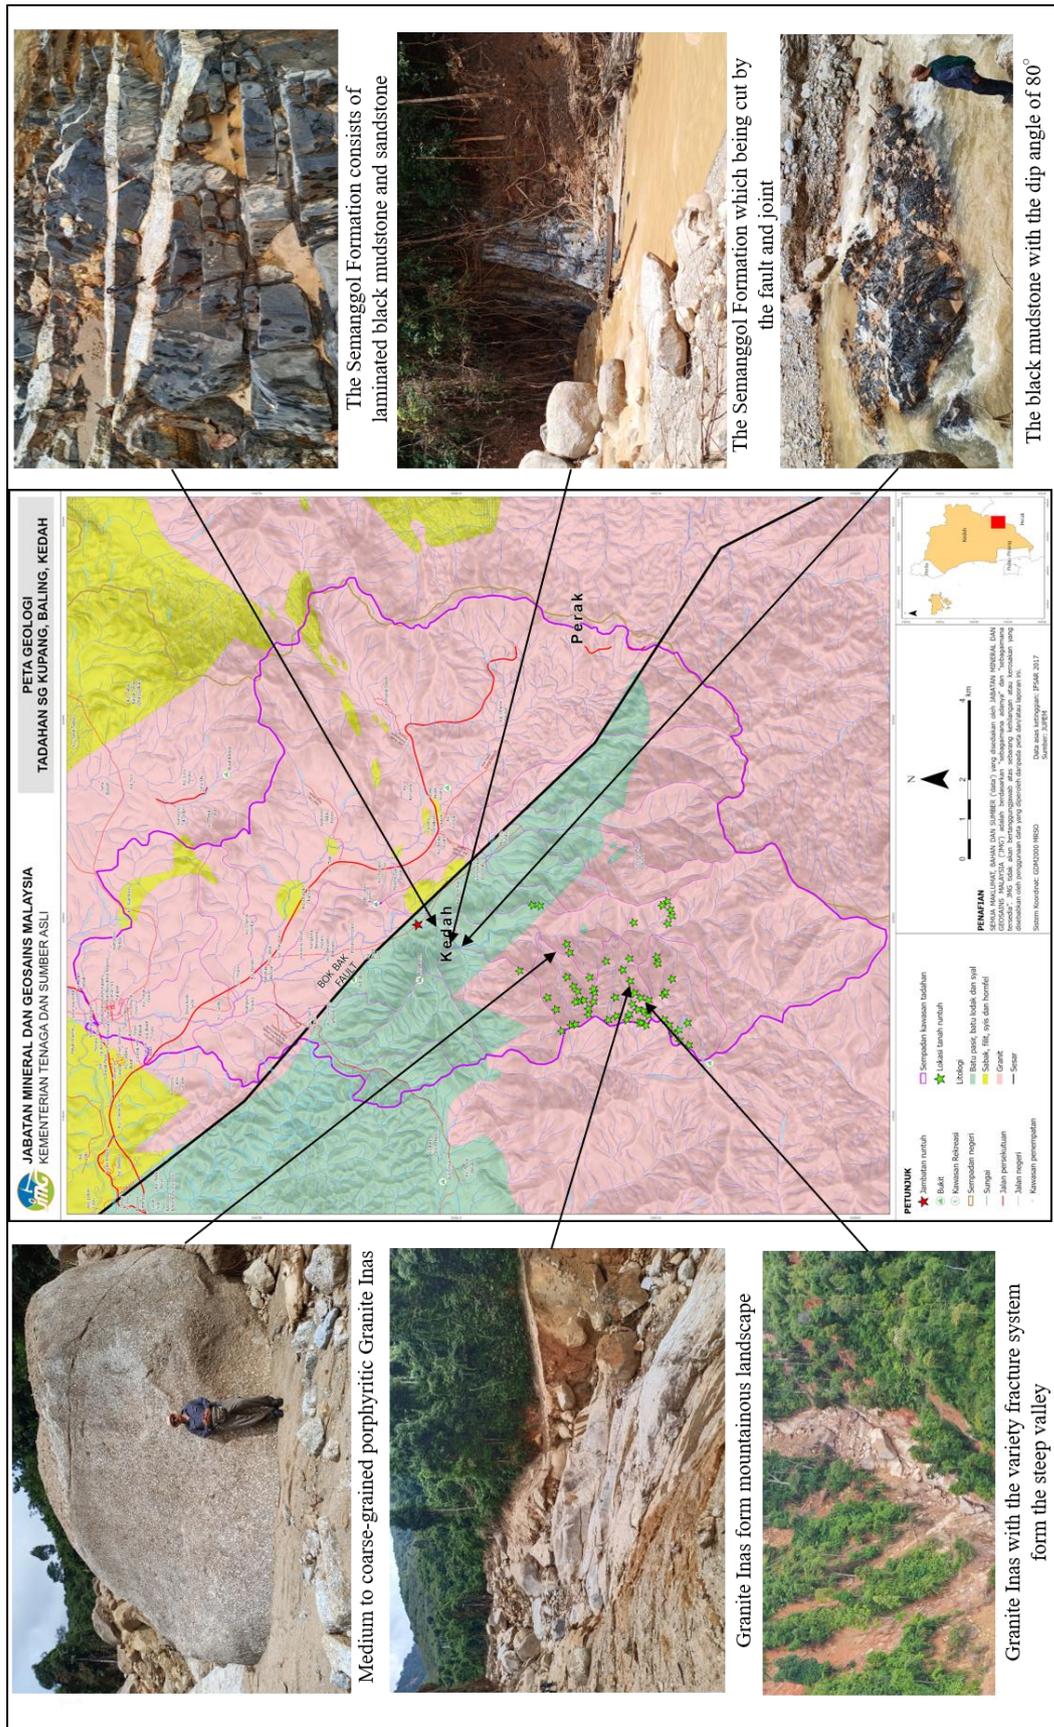
The entire Sungai Kupang Basin is underlain by three main rock units, namely Inas Granite in the upstream part of the basin with high topography (ranging from 200 m to more than 1450 m), Semanggol Formation in the middle and Kroh Formation which forms the low and undulating hills at the very downstream (Fig. 2). The Inas Granite in the upstream covers almost 70% of the rock distribution in the Sungai Kupang Basin area. The granite consists of medium- to coarse-grained porphyritic granite formed by quartz, feldspar and biotite minerals. The Semanggol Formation, which consists of laminated black mudstone and sandstone, forms the lowland that underlies almost 25% of the Sungai Kupang Basin area. This formation is separated from the granite by a major fault known as Bok Bak Fault. This fault has formed a clear topographic or slope change from steep in the granite area to very gentle land in Semanggol Formation. The

The Bok Bak Fault is oriented in a direction of northwest-southeast (NW-SE) and affects the downstream direction of Sungai Kupang. It also produced a shear zone that created a weak zone between the granitic and sedimentary rocks, producing minor faults (weak zones on the slope) as well as influencing the geomorphology of the Sungai Kupang catchment area.

Fig 2: The Geology Map of the Sungai Kupang Basin (Source: JMG, 2022)

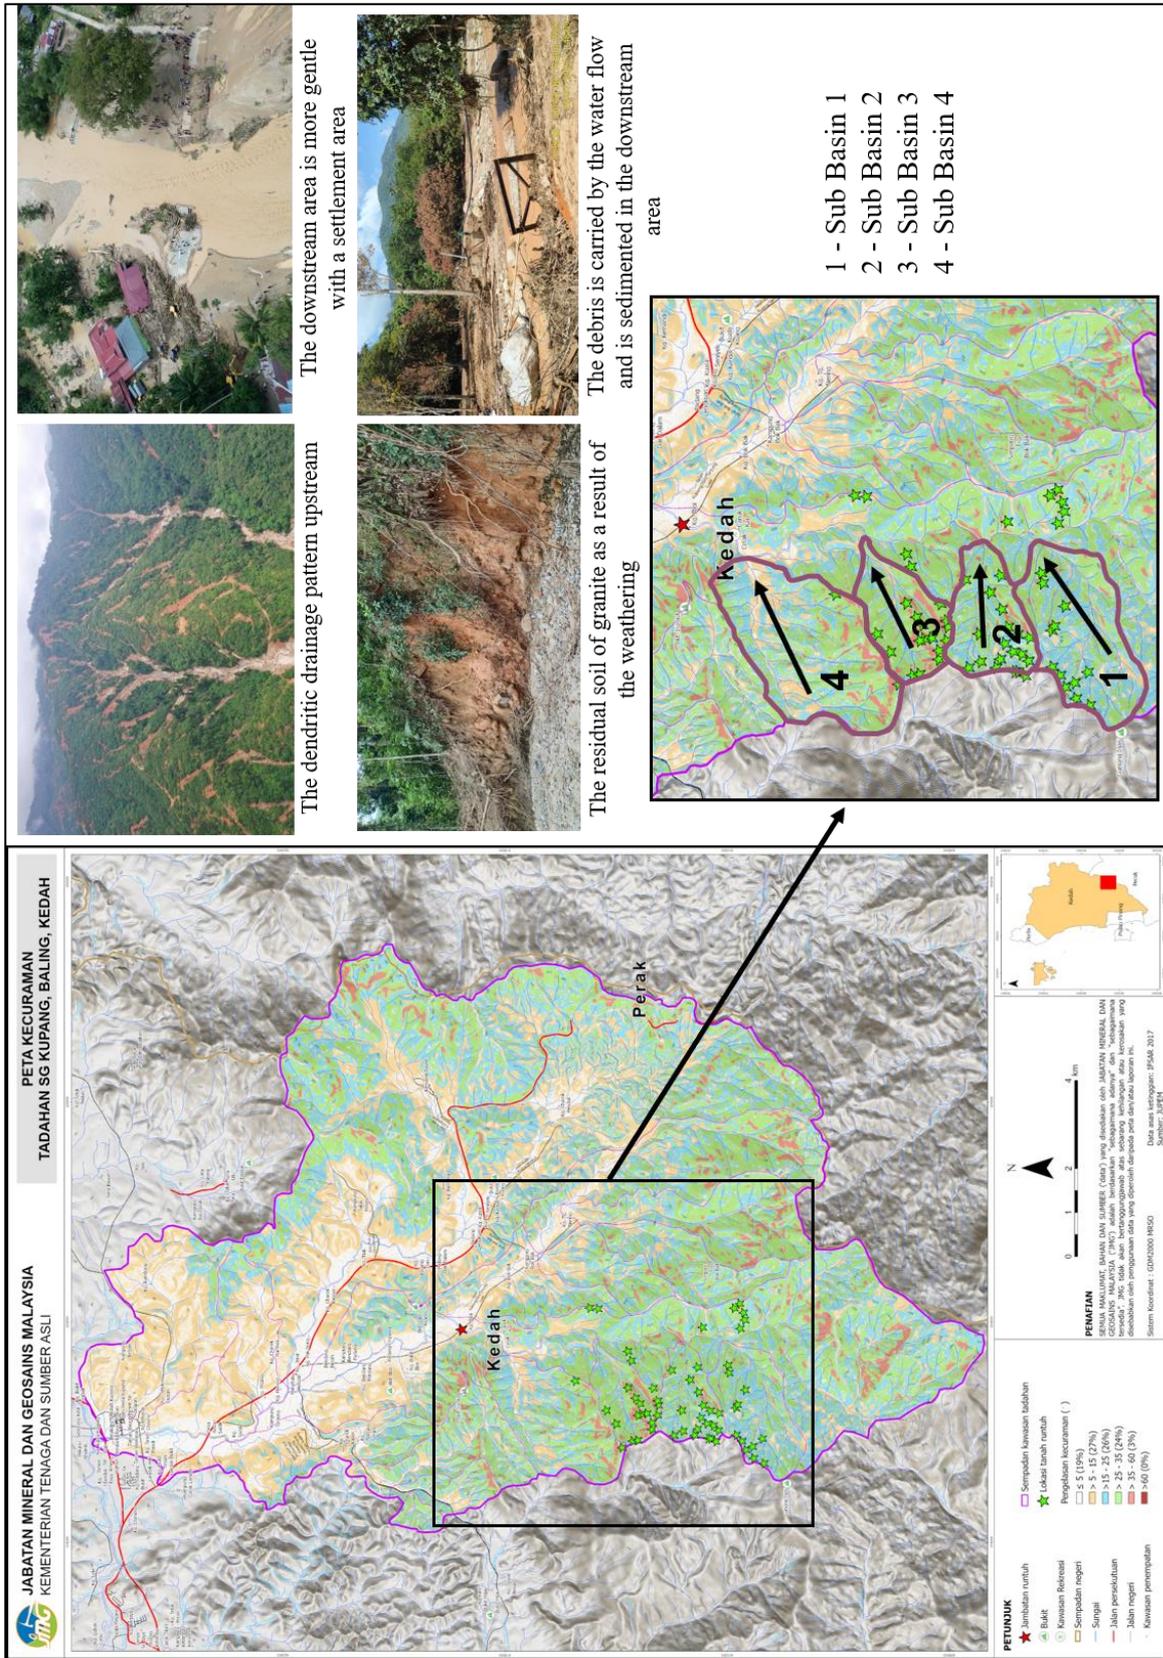
upstream to low-lying area are controlled by the underlying rock and lithological units. Between the peaks and the lowlands, there are river channel with V-shaped that became the transport zones of debris. The dendritic drainage pattern upstream form four (4) sub-basins that eventually merge with the main river forming the Sungai Kupang Basin (Fig. 3).

Fig. 3: The Geomorphology Map of the Sungai Kupang Basin (Source: JMG, 2022)

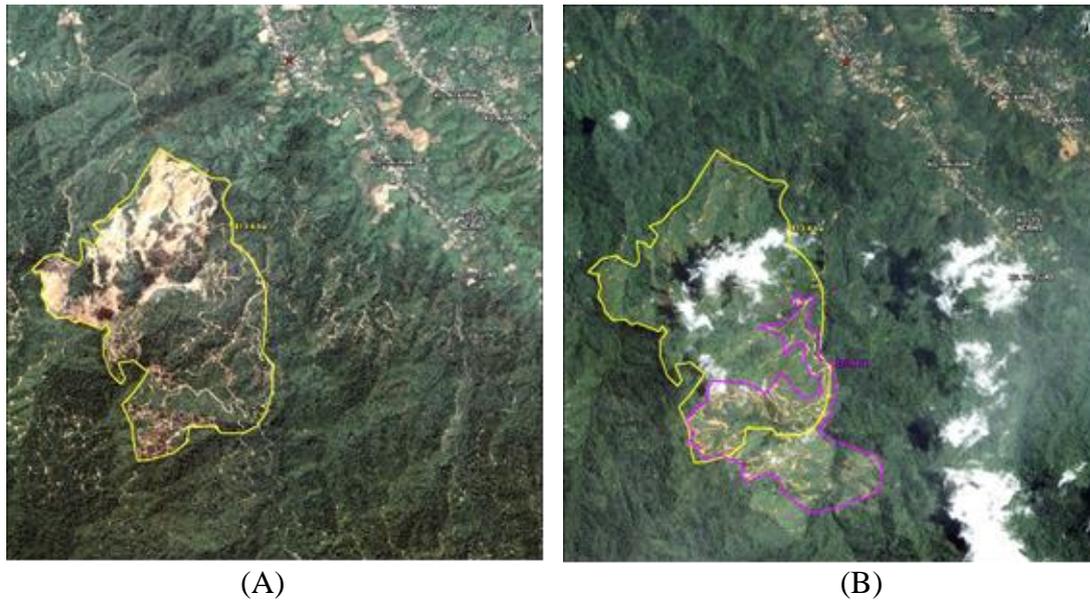
Based on satellite images released by the Malaysian Space Agency (MySA), 813 hectares in Compartment 8 were deforested in 2019, this has led to an erosion rate of 743,895 metric ton/year (Fig.4.A). For the first 6 months of 2022, the area has been deforested and turned into agriculture land with an area of 980 hectares and the annual erosion rate is 57,330 metric ton (Fig.4.B). The rate of erosion used for the

calculation of the load rate that goes into the river channels based on soil erosion and siltation studies by Gharibreza et al. (2013). In summary, within 3 years from 2019 to 2022, the rate of erosion that goes into the river channels in Sungai Kupang Basin is estimated at 1,011,006 metric ton as shown in Table 2.

Fig. 4. (A) Cleared Area (yellow line) in 18 Mac 2019 (813 hectares) (B) Cleared Area (yellow & purple line) in 02 July 2022 (980 hectares) (Source: MySA, 2022)

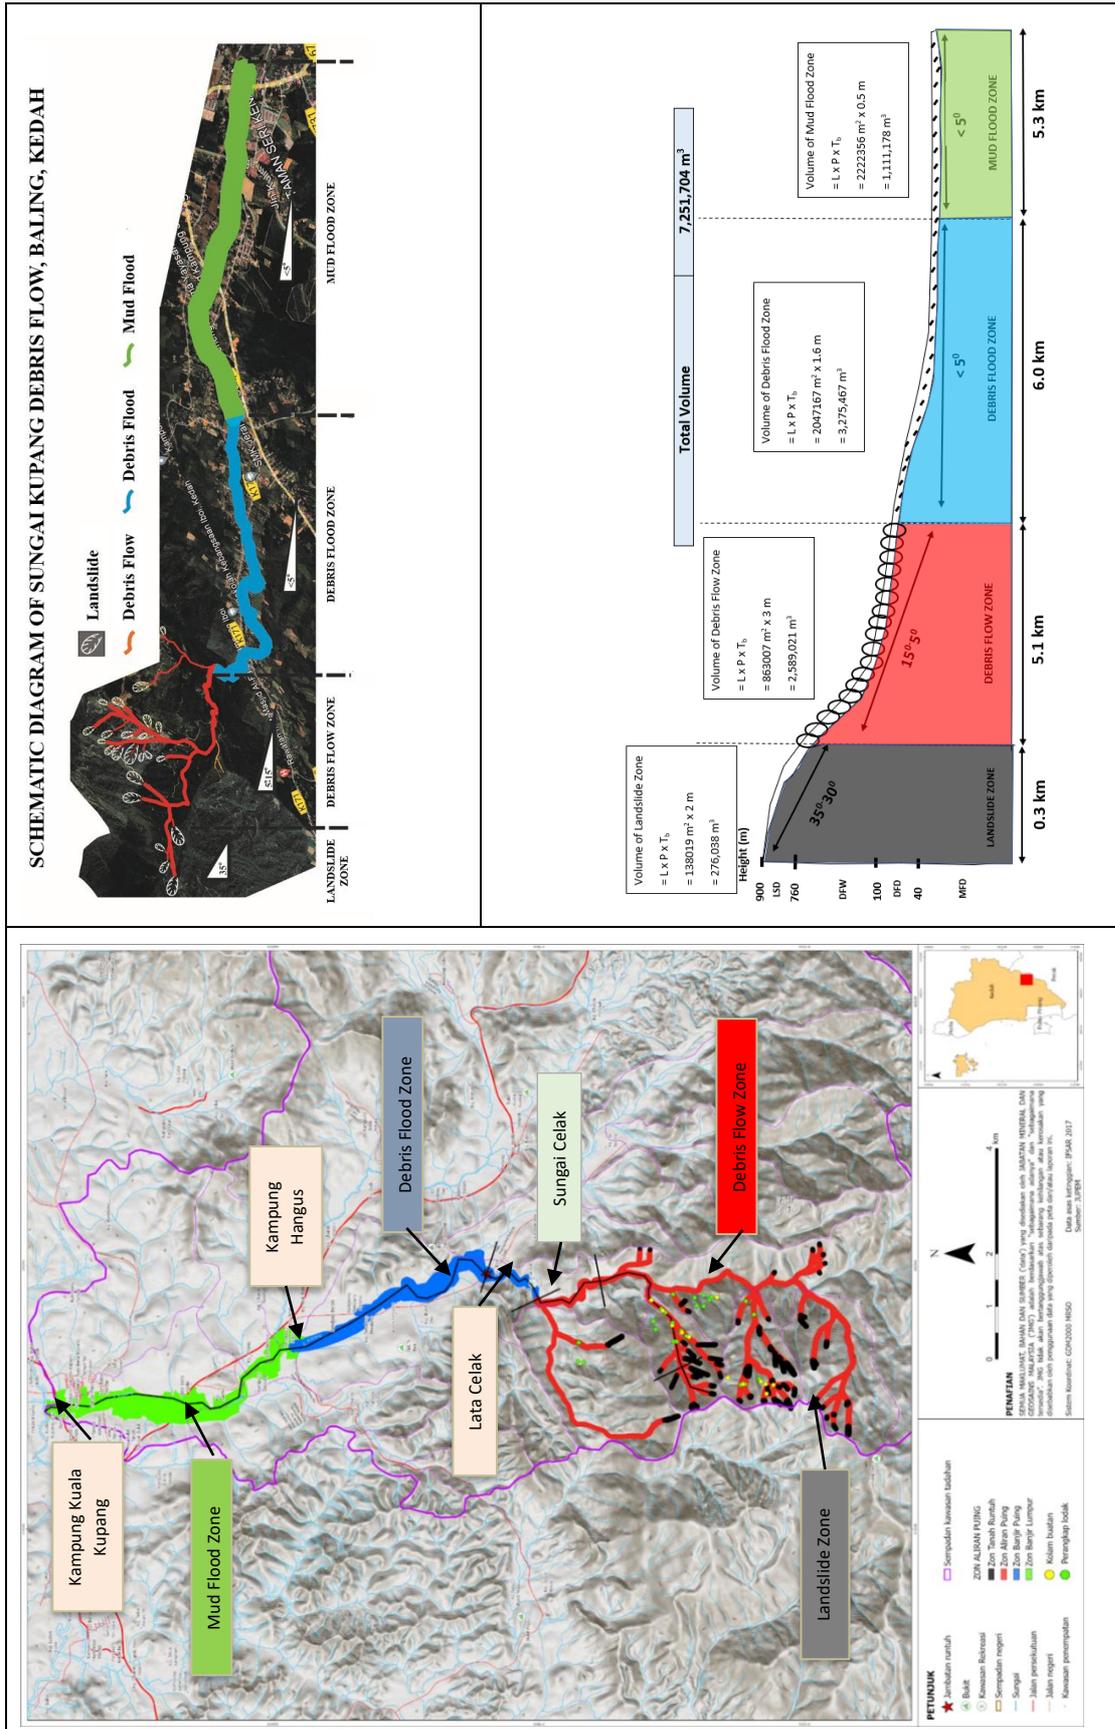
Site investigation are carried out by walk-over survey along the affected river channels from 16-23 July 2022 and aerial survey conducted on 27 July 2022. Based on the site investigation, the disaster area can be divided into four zones; namely the landslide zone, the debris flow zone, the debris flood zone and the mud flood zone (Fig. 5).

Fig. 5: Sungai Kupang Debris Flow Zone Map (Source: JMG, 2022) (Landslide Zone - Black), (Debris Flow Zone - Red), (Debris Flood Zone - Blue), (Mud Flood Zone - Green)

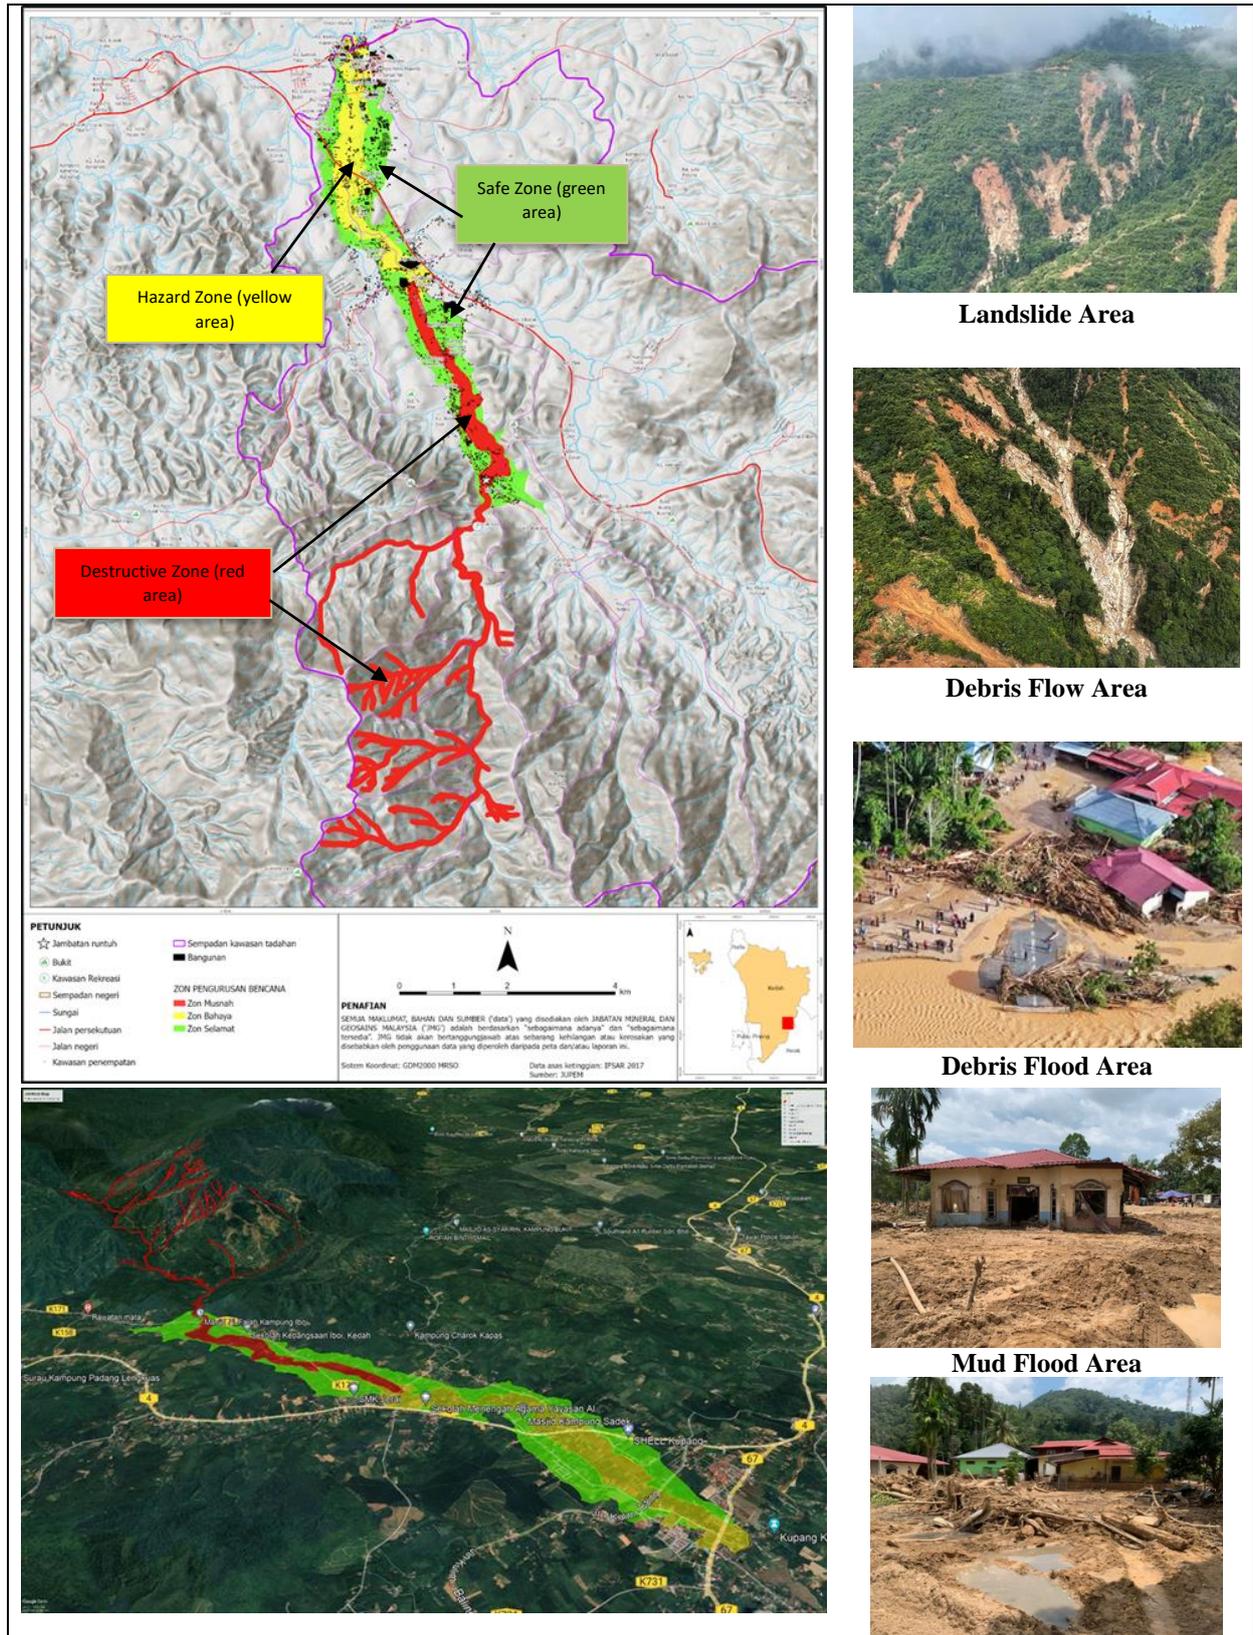
Based on field investigations and geomorphological analysis, a Debris Flow Geological Hazard Map is provided. This map is intended to be used as a post-disaster development planning guide in areas where the debris flow disaster has occurred. This hazard map takes an approach which the disasters that have occurred can recur in the future and the rebuilding process should take the current experience into account. For this hazard map, three post-disaster management zones were introduced, namely the Destroy Zone, the Hazard Zone and the Safe Zone (Fig. 6).

Fig. 6: Sungai Kupang Debris Flow Geological Hazard Map (Source: JMG, 2022) (Destructive Zone - Red), (Hazard Zone - Yellow), (Safe Zone - Green)
