Geological Factors Contributing to Landslide Incident in Malaysia - Case Study Batang Kali Landslide Disaster, Hulu Selangor, Selangor.

The Batang Kali landslide that occurred at 2.08 a.m. on 16 December 2022 had struck almost entirely the agriculture and campsite areas of Father's Organic Farm, Batang Kali, Hulu Selangor, Selangor. The deadly landslide claimed 31 lives including 13 children and 61 survivors were rescued. The search and rescue (SAR) operation was carried out immediately and continued for nine days before it ended after the last victim was found. The Department of Mineral and Geoscience Malaysia (JMG) was informed of the event and actively involved in conveying geological information during the SAR operation. JMG was also responsible for conducting a forensic investigation to understand the geological factors that contributed to this catastrophic event. An extensive field geological study including LiDAR data capture, geophysical surveys, geological surface mapping, hydrogeological, and in situ field testing were carried out. These data were analyzed to ascertain the causal geological factors and establish of subsurface profile for landslide simulation modeling. Th

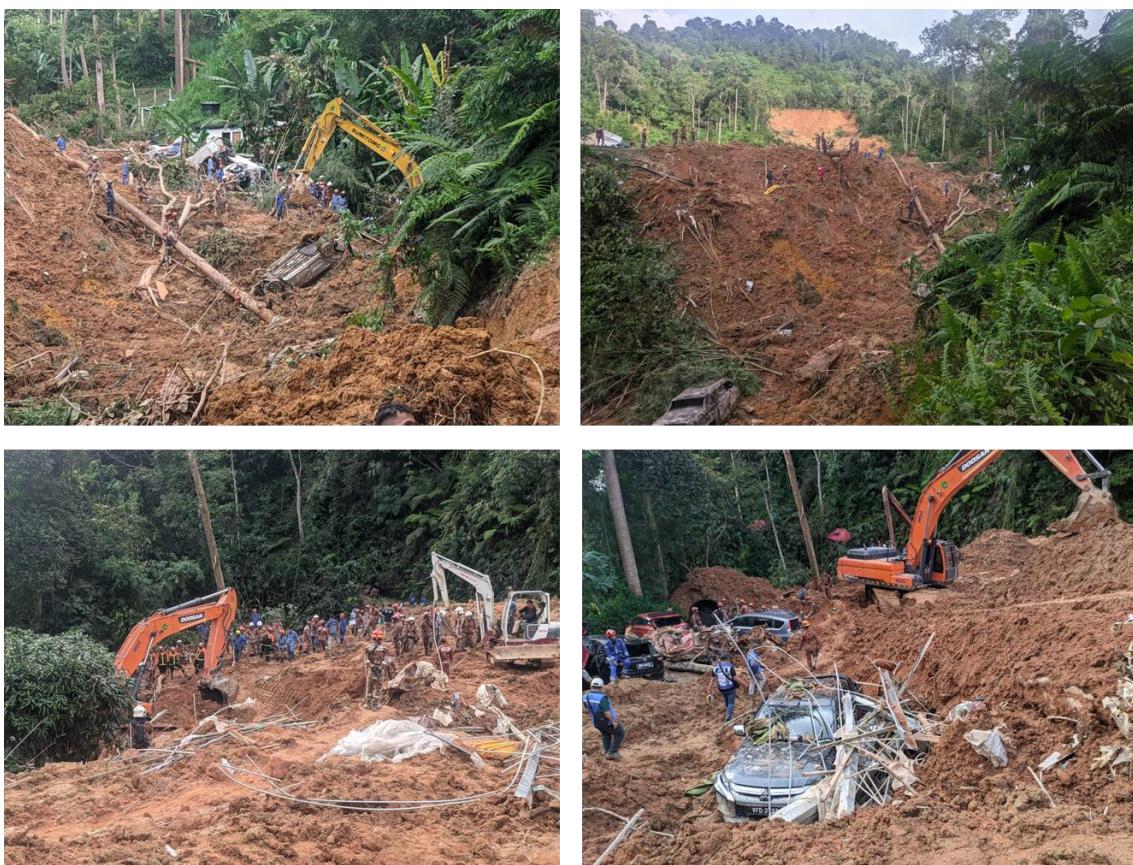
Fig. 1: Photo during Search and Rescue (SAR) Operation at the campsite and agriculture area

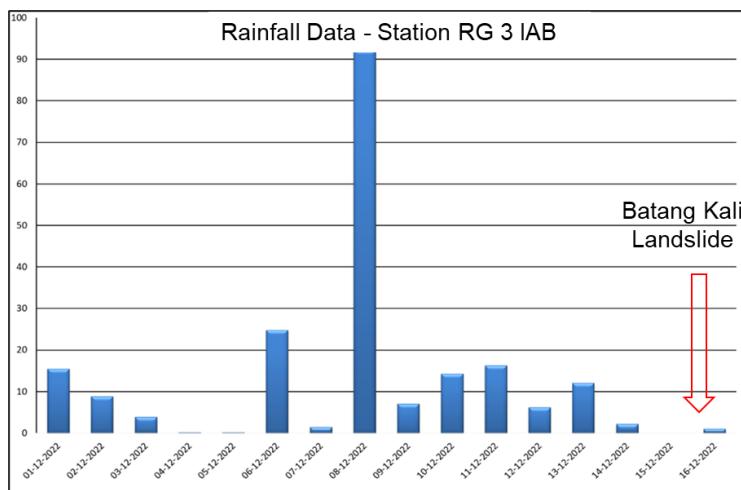
data for the period of 1 December to 30 December 2022 shows the heavy rainfall outflow of the Northeast Monsoon occurred in early December 2022 with the highest rate at 92.2mm a day. The cumulative rainfall record 15 days before the incident for the nearest Station (RG 3 IAB) was also at a level of 205.6mm. However, there was no rainfall recorded during the day of the incident.

Fig. 2: The cumulative amount of rain 15 days before the event for the closest station RG 3 IAB was 205.6mm with the highest amount of daily rainfall being 92.2mm.

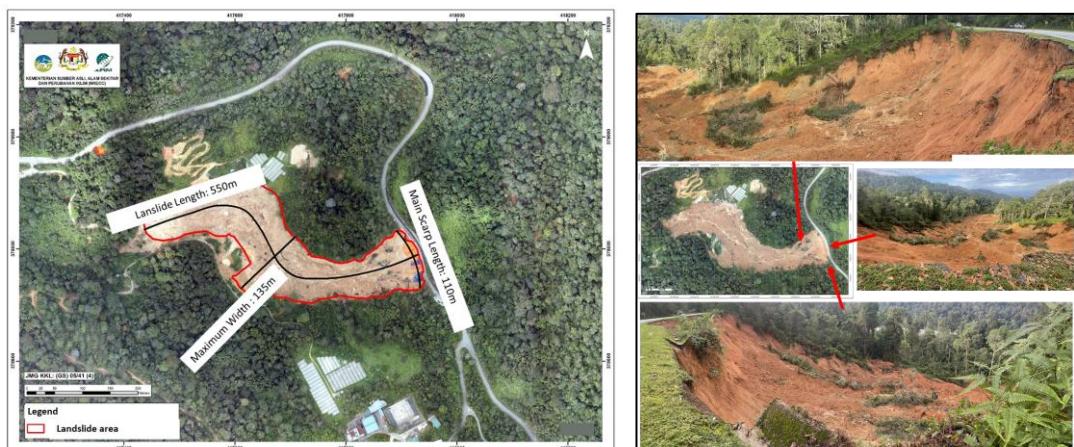
The landslide occurred on a man-made slope that was originally constructed to provide a platform for the Batang Kali-Genting Highlands Road. The cut slope at the top of the road platform is still intact, while the fill slope at the bottom has failed. The height of the fill slope from the road platform to the foot of the slope is approximately 50m and the gradient of the slope is approximately 25° - 30° . The width

of the main scarp is 110m, the depth is 14m and the length of the path and accumulation area is approximately 550m (Fig. 3). The total volume of the landslide debris is approximately 282,170 m³ which includes the initiation zone and the accumulation zone. In addition, the landslide also transported soil materials, boulders, and trees along the route and deposited at the lower and sloping part of the valley downstream. According to Varnes (1978), landslides are classified as complexes that combine a rotational slide with earth flow.

Fig. 3: Dimension of the landslide and the photo of the main landslide body.

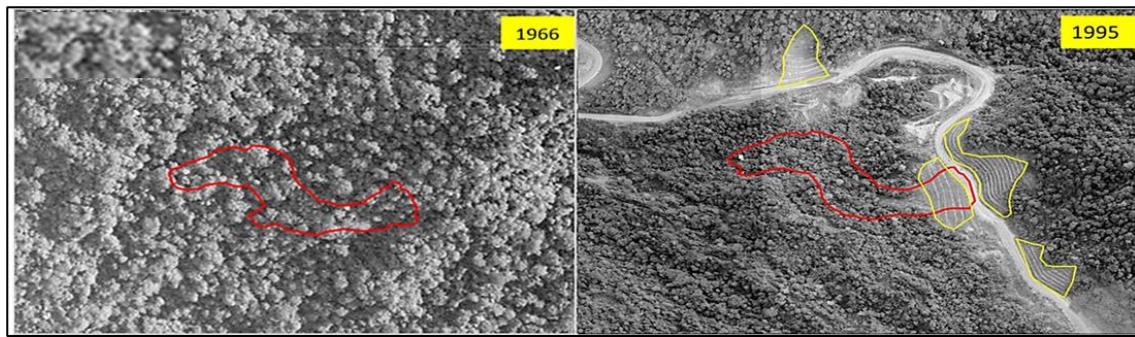
Analysis of the 1966 aerial photo imagery shows that the investigation area was covered by forest and there was no disturbance on the natural terrain. The 1995 aerial photo image also indicates the condition after the road was ready to be built where there were activities of cutting and filling the slope. Slope profiling also has been carried out on the upper slope and lower slope of the road platform around the landslide area (Fig.4). Besides that, analysis of satellite images from Google Earth starting from 2002 to 2021 shows that several land use changes have taken place within the investigation area. Land use patterns changed significantly from February 2015 when land clearing activities, construction of greenhouses for agricultural activities, and construction of permanent structures took place (Fig. 5). The qualitative interpretation was based on the elements of location, size, shape, hue, texture, and pattern of the objects in the images used. Signs of slope instability and landslides are not clearly visible in the vicinity but rather there is a sign of erosion at a modest to high grade in areas that were explored before vegetable planting and rain protection structures were built. On the other hand, analysis of Interferometric Synthetic Aperture Radar (InSAR) data revealed some changes in the earth's terrain prior to the failure in the investigation area. The method of monitoring using InSAR satellites is seen to be an effective monitoring tool for landslide risk. The analysis was divided into 5 monitoring zones to assess any landform changes (Fig. 6). Zone A covering the foot of the slope has shown a downward movement trend with a rate of 21.25 mm/year starting on 3 December 2022 until 15 December 2022 which was the day before the landslide occurred. Likewise, Zone C which includes the upper slope and lower slope has also indicated a downward movement with a rate of 21.48 mm/year starting on 24 July

Fig. 4: Aerial photo of the landslide area in 1966 and 1995 which red polygon indicates landslide area. (Source: Department of Survey & Mapping Malaysia)

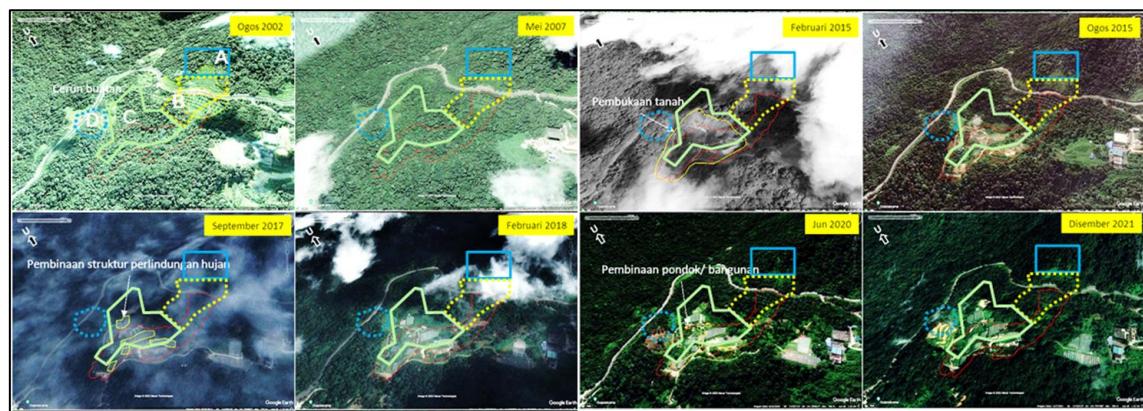
Fig. 5: Land use change from 2002 to 2021 based on satellite imagery. (Source: Google Earth)

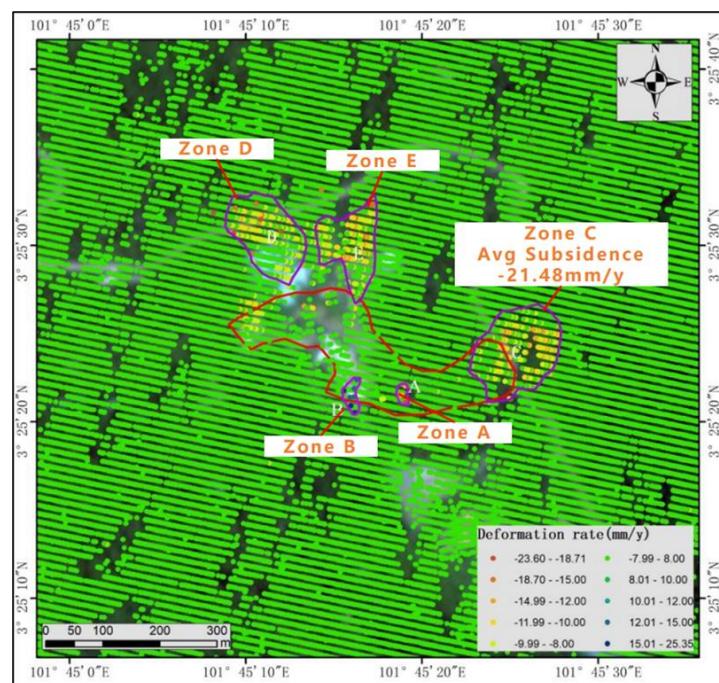
Fig. 6: Movement analysis using InSAR satellite data within the investigation area (Source: Spacegen Sdn Bhd).

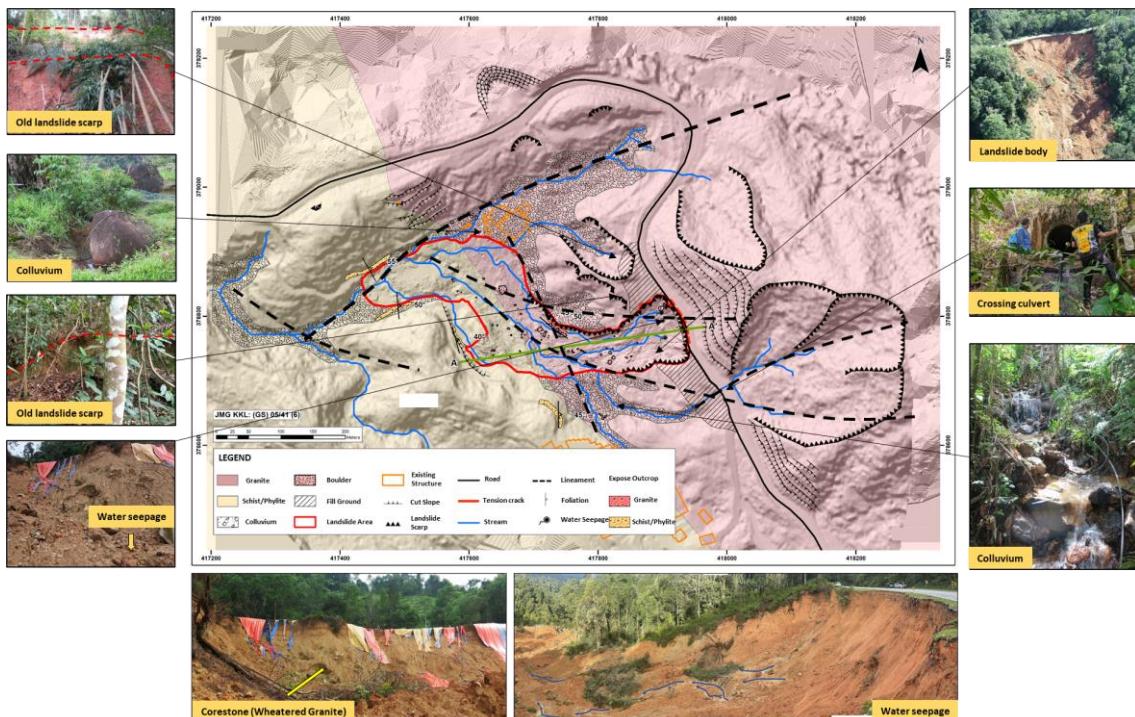
Fig. 7: Geomorphological Map of the landslide (Department of Mineral and Geoscience Malaysia, 2023)

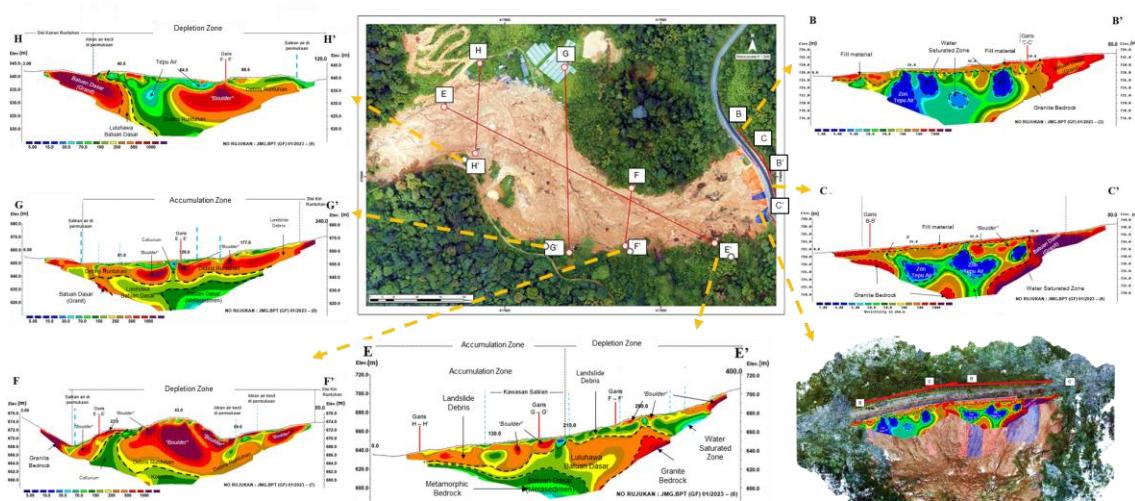
A geophysical survey application in landslide investigation aims to understand the subsurface characterization, ground-water regime, and localization of the shear plane (Hussain et al., 2022). The 2-dimensional electrical resistivity method was used in the investigation with a total of 8 survey lines within the landslide body (Fig. 8). The result shows that the water-saturated zone was found in the main landslide scarp area where the resistivity values range from 1 Ω m

to $9 \Omega\text{m}$. This zone consists of materials that have high porosity and permeable properties that allow water and electric current to flow easily. Whereas within the landslide area, water saturated zone in the landslide debris was interpreted at the low resistivity value zone range from $5 \Omega\text{m}$ to $50 \Omega\text{m}$. Medium resistivity value zones ($31\Omega\text{m}$ - $500\Omega\text{m}$) are interpreted as the material within the landslide debris that can be found from the surface down to a depth of 20m followed by a layer beneath

the collapse debris layer that is interpreted as weathered rock and colluvium. The third layer at the bottom is interpreted as bedrock. The lower magnitude values indicate the different lithological nature of the bedrock and are interpreted as metamorphic rocks. The high intensity zones ($500\Omega\text{m}$ - $5000\Omega\text{m}$) within the landslide debris layer are interpreted as "boulders" and granite-type bedrock based on information from the geology of the area.

Fig. 8: Geophysical result of the landslide area

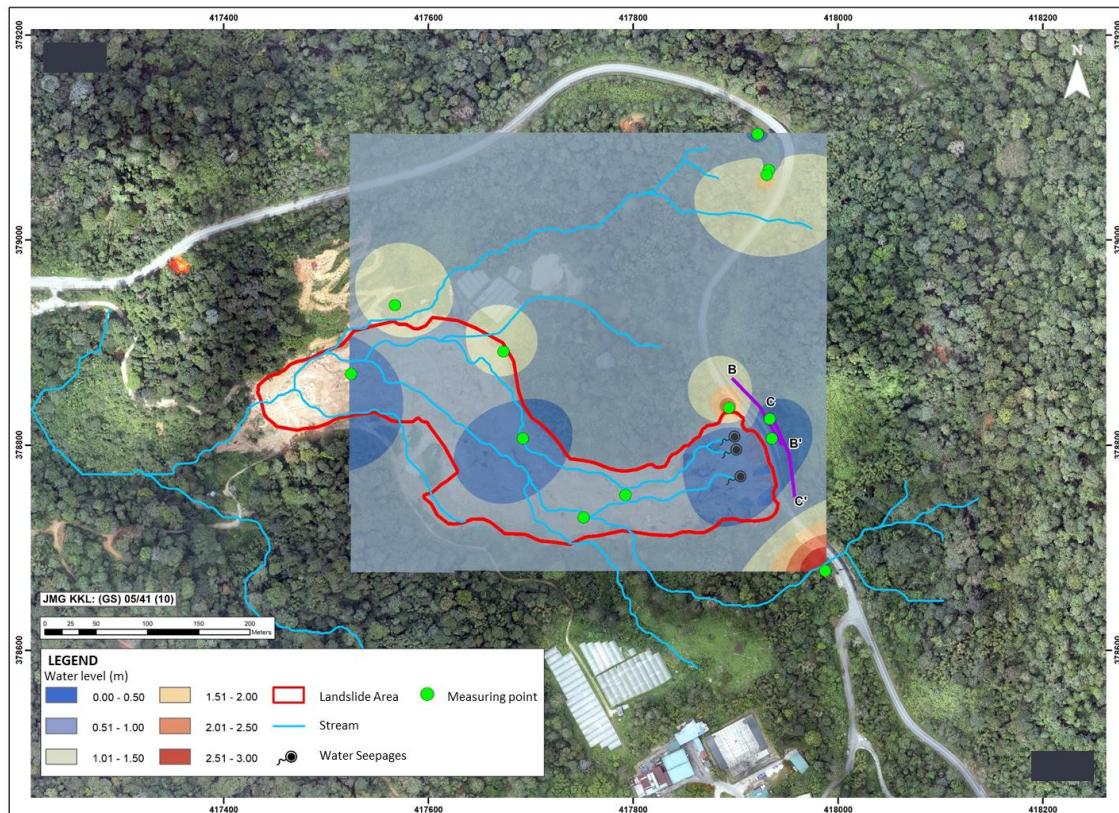
Besides that, hand auger holes and Mackintosh probes testing locations were utilized in measuring the groundwater levels a week after the incident. Based on the analysis of the water level measurements in the field, an isopach map of the groundwater level from the ground surface was generated

(Fig.9). Generally, the direction of underground water flow in this area is consistent with the hydraulic head contour which flows from the east to the west of the site. The high water table was found in the main landslide scarp area in line with the results from the geophysical study using the 2D electrical resistivity survey method which indicates the water-saturated zone.

Fig. 9: The isopach map of groundwater level from the ground surface in the landslide area

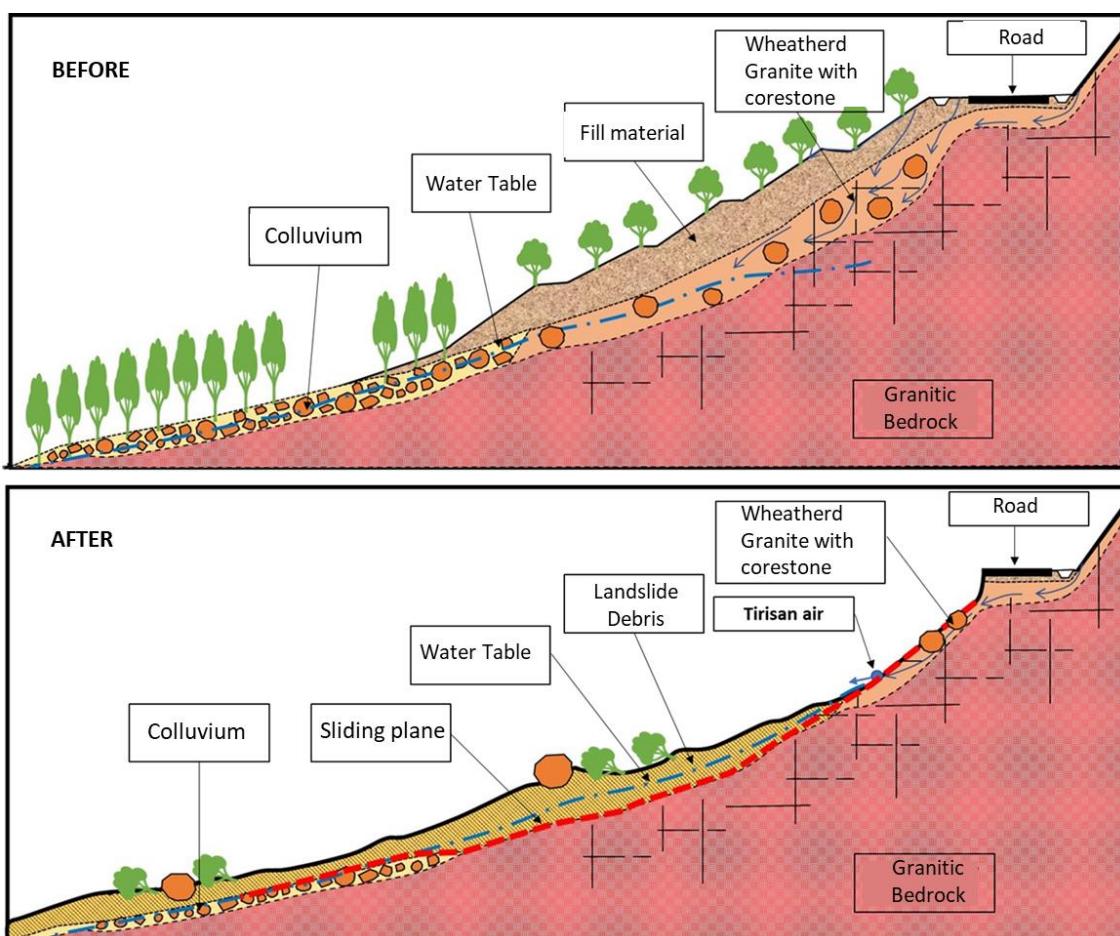
Generally, geology, geomorphology, climate, and anthropogenic activities, are factors controlling the stability of a slope (Komadja et al., 2020). The Batang Kali landslide is known to have been caused by geological elements within the slope and the presence of underground water. The road platform has been built on top of a cut slope while the fill slope has been constructed on top of weathered granite containing a rock boulder named corestone and colluvium layer at the foot of the slope which is characterized as a geological sensitive deposit due to loose and uncompacted materials. The presence of groundwater flow in the slope has formed a water-saturated zone at the foot of the slope which results in the soil matrix becoming loose and contributes to the instability of the entire slope. Apart from that, anthropogenic factors and land-use activities in the vicinity also significantly contributed to the instability of the slope thus increasing the risk of landslide.

Figure 10 depicts the schematic diagram of the landslides.

Fig. 10: Schematic geological crosssection of the landslides.

investigation and analysis as well. Thus, the findings of the investigation should also be used in designing the slope repair work and mitigating measures in the area. Additionally, it is crucial to assess the stability of existing slopes in the vicinity of the landslide area for proper mitigation measures as well as a routine slope maintenance of the man-made slope should cover the entire slope area.
