THAI GEOSCIENCE JOURNAL

Vol. 4 No. 6 July 2023

Rock Failure Assessment on Paleo-Collapse in Case of the Prasat Hin Pan Yod tourist site, Satun Geopark, Thailand

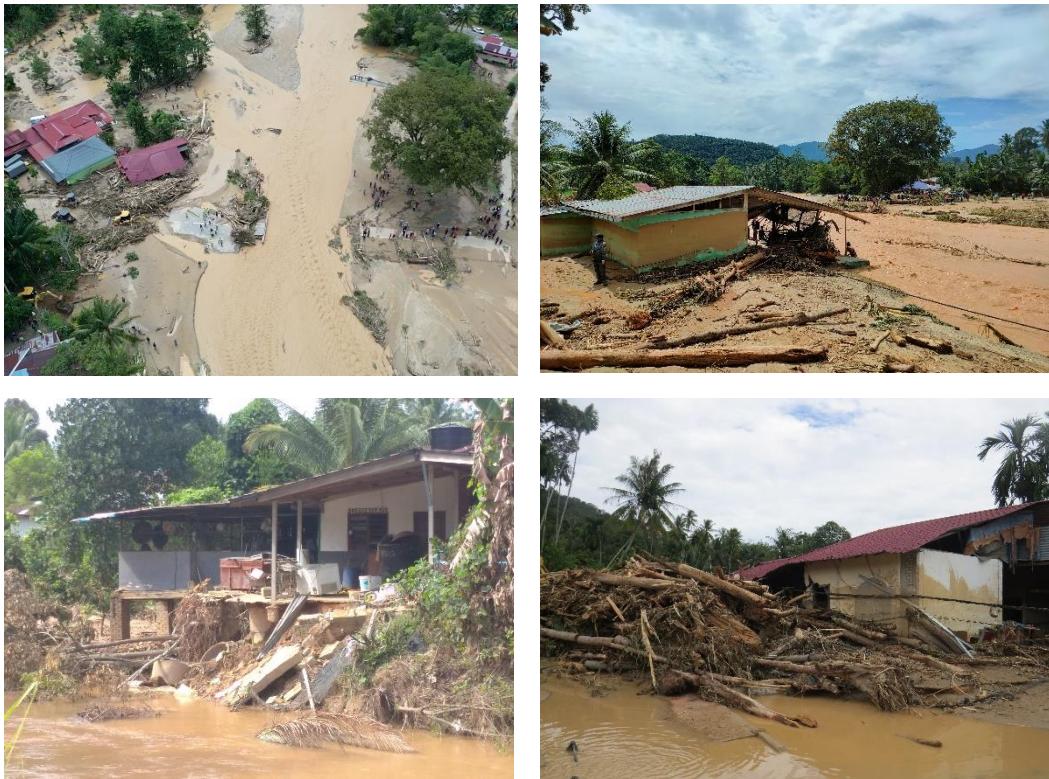
dozens of landslides in the ridges and steep slopes. Material with high water saturation formed debris flow and consequently turned into a debris flood as the water content increased. The Kampung Iboi Bridge became a

'temporary dam' which caused the debris flood in the downstream area when it burst. After the debris was deposited, the leftover materials mainly consist of mud and silt formed the mud flood further downstream.

Fig. 1: Photo of Kampung Iboi, Sungai Kupang, Kedah (the most affected area)

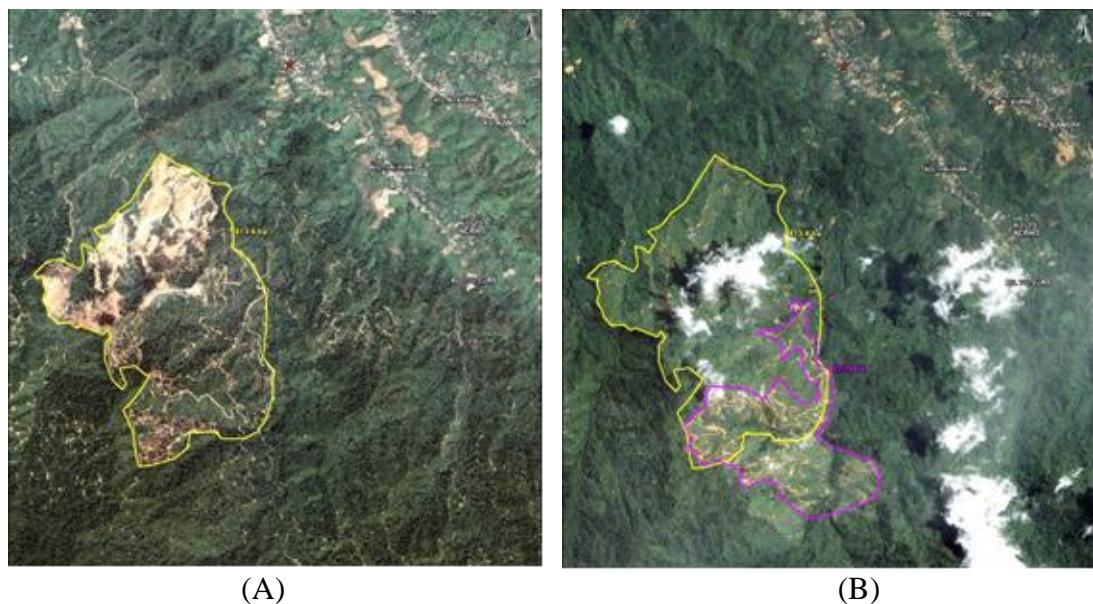
Fig. 4. (A) Cleared Area (yellow line) in 18 Mac 2019 (813 hectares) (B) Cleared Area (yellow & purple line) in 02 July 2022 (980 hectares) (Source: MySA, 2022)

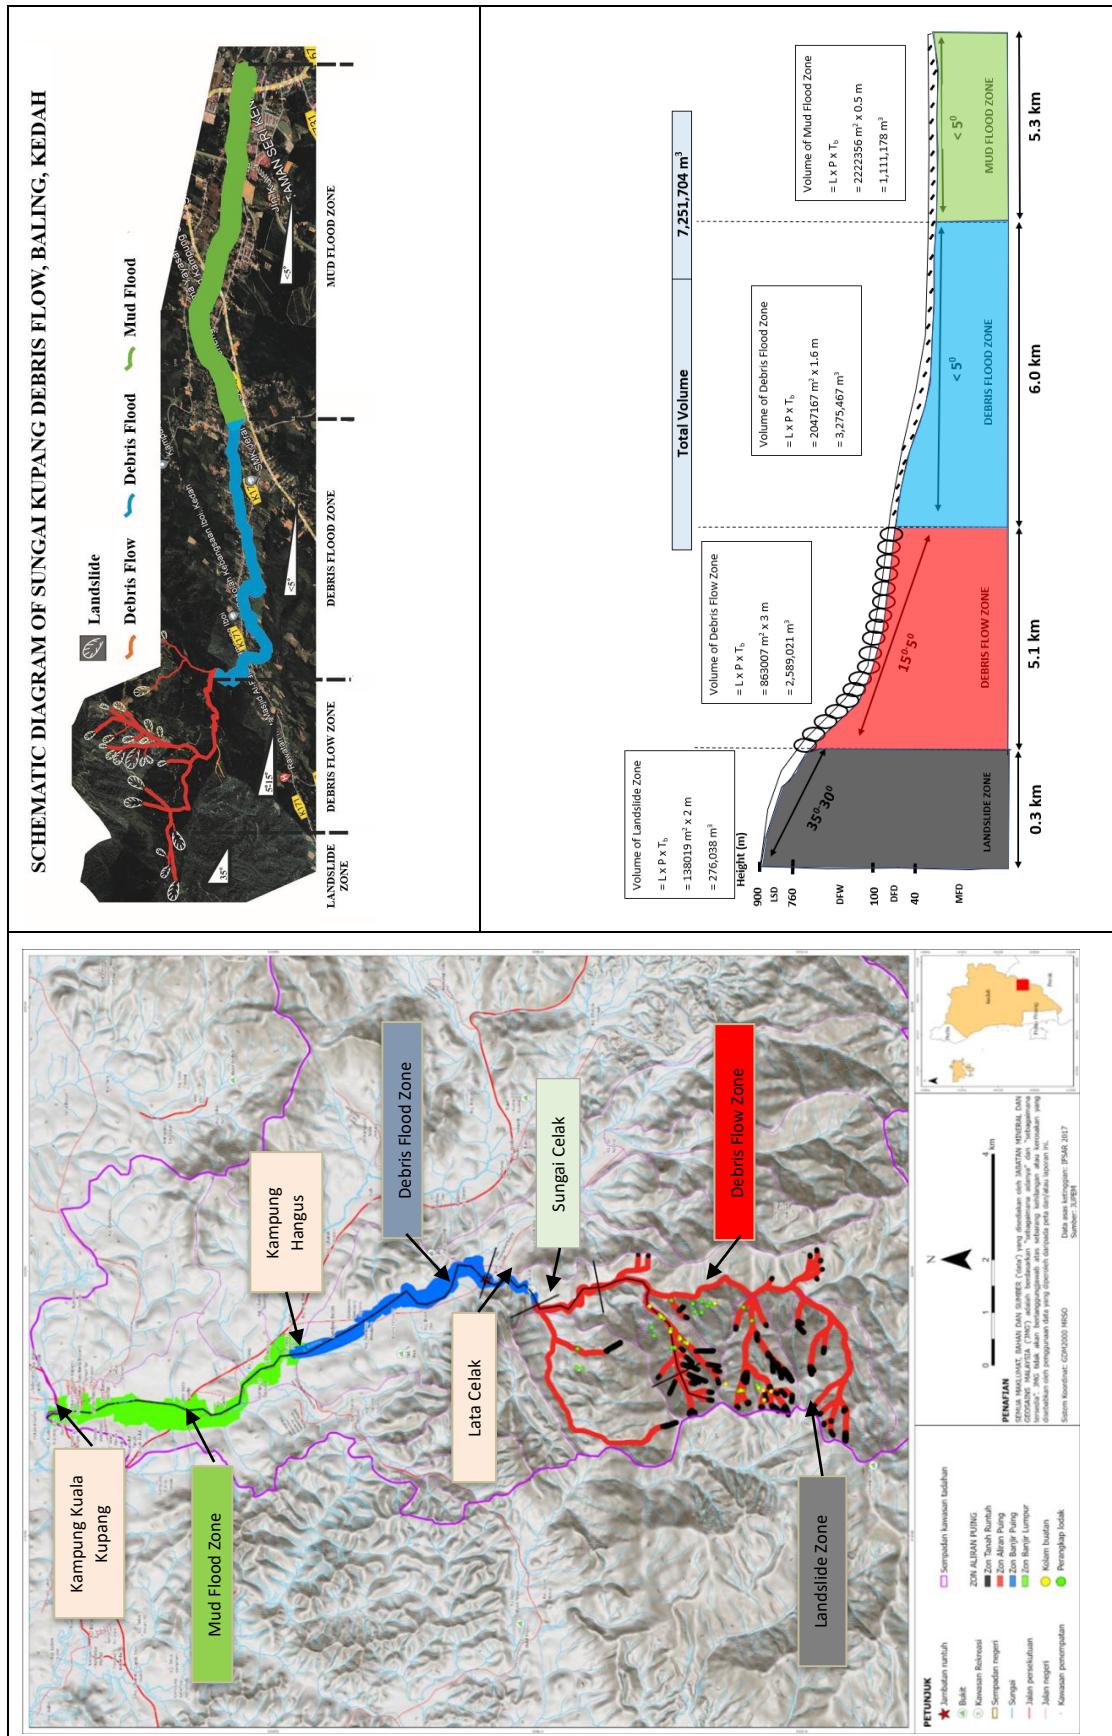
Field surveys, satellite imagery and UAV analysis showing the debris flow in four (4) sub-basins sizing from 20 m width, flowing to the main stream of Sungai Kupang with an average size of 40 m. The length of debris flow is following the length of the river, and the longest debris flow is reaches to 5 km. The debris flow with thickness of 3.0 m transports the rock blocks (2.0 m to 5.0 m in diameter), tree trunks, sand, silt and mud along the stream with a cumulative volume of 2,589,021 m³. Suspended silt and mud in the water can be

After the debris containing sand and tree trunks are stranded, the floodwater contains only high volume of silt material. Depending on the height of the water level, mud flood can overflow on the flood plains extensively. The recorded mud flood level ranges from 0.2 m to 2 m with the width ranges from 150 m to 680 m and estimated volume of $1,111,178 \text{ m}^3$. Mud flood zone was detected as far as 5.3 km from Kampung Hangus to Kampung Kuala Kupang and affected 36 villages along Sungai Kupang. The distribution of these zones is very wide and involves damage to public facilities and causes discomfort to the affected residents.

Fig. 5: Sungai Kupang Debris Flow Zone Map (Source: JMG, 2022) (Landslide Zone - Black), (Debris Flow Zone - Red), (Debris Flood Zone - Blue), (Mud Flood Zone - Green)

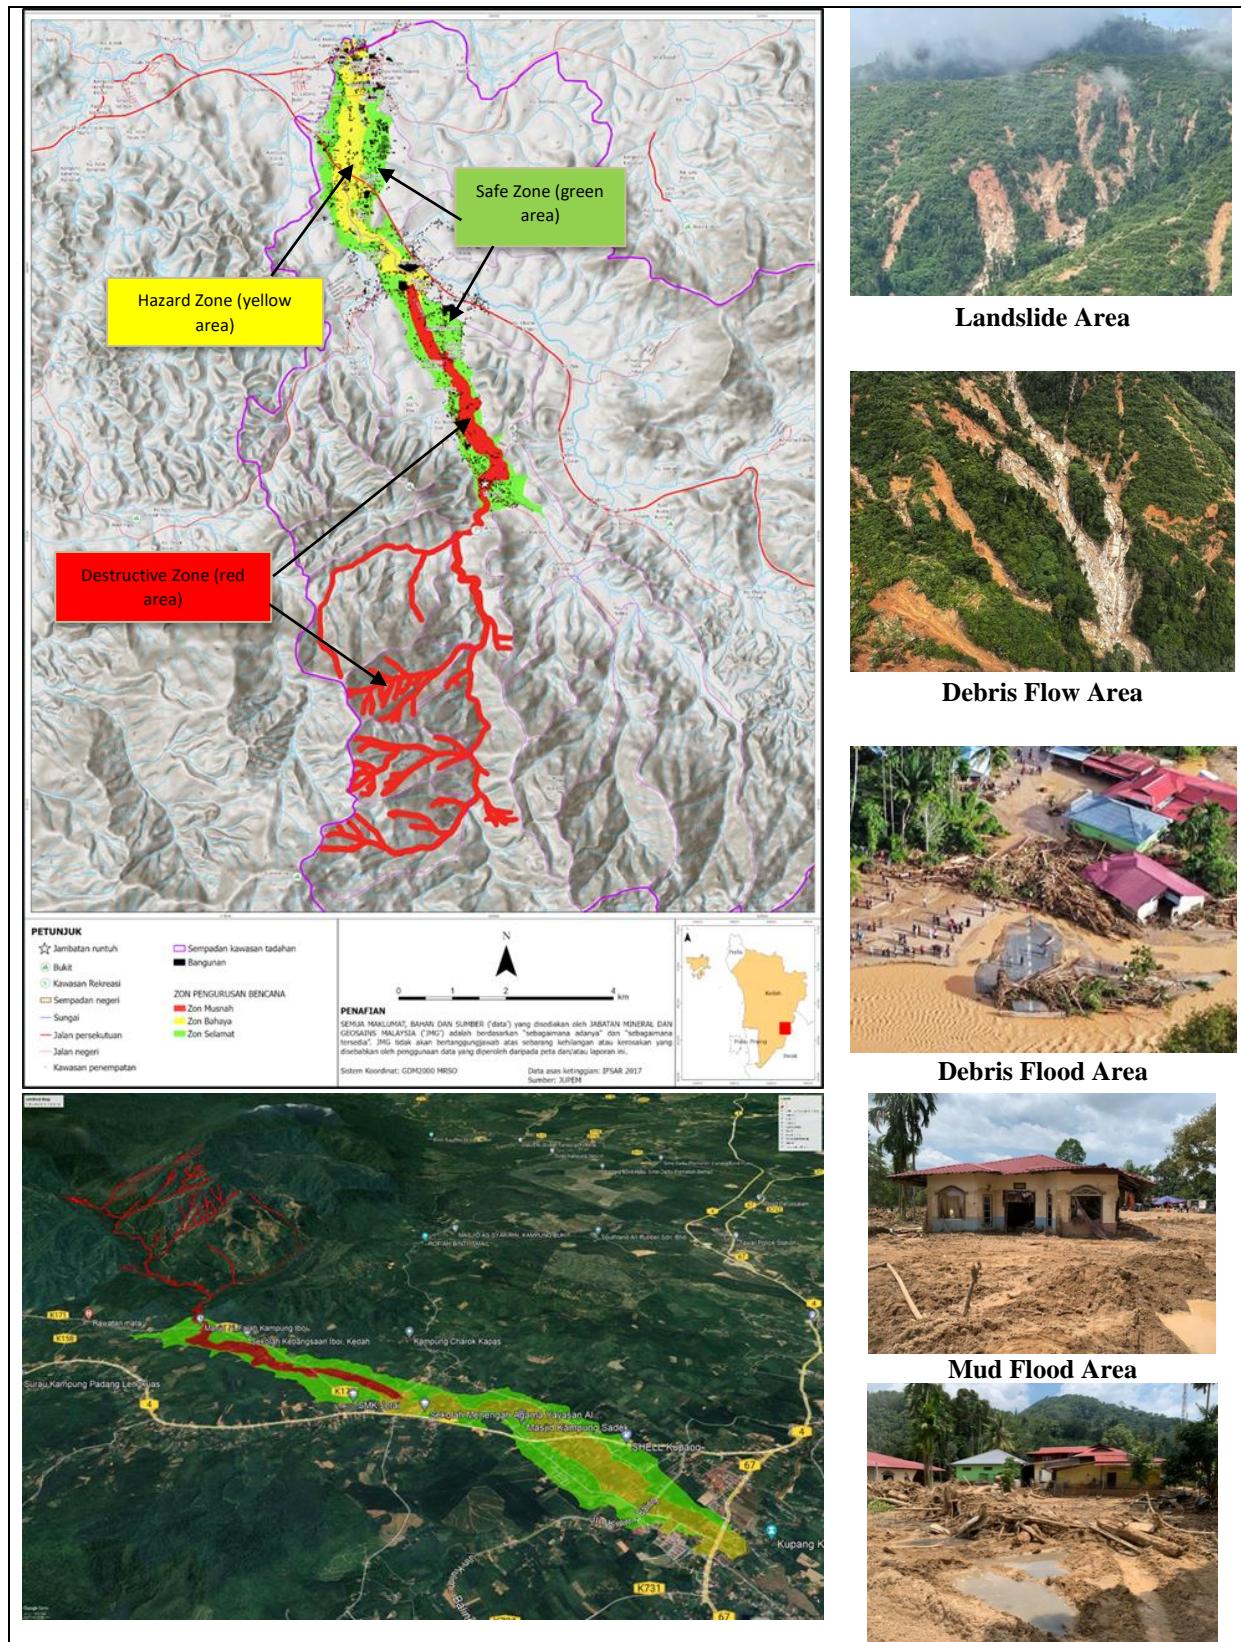
Based on field investigations and geomorphological analysis, a Debris Flow Geological Hazard Map is provided. This map is intended to be used as a post-disaster development planning guide in areas where the debris flow disaster has occurred. This hazard map takes an approach which the disasters that have occurred can recur in the future and the rebuilding process should take the current experience into account. For this hazard map, three post-disaster management zones were introduced, namely the Destroy Zone, the Hazard Zone and the Safe Zone (Fig. 6).

The Hazard Zone involves areas affected by mud flood. Based on field surveys, most of these areas experienced mud flood at the level of waist-down (2 to 3 feet). Most losses involve property damage and discomfort, without building destruction or death. This zone can still be occupied or build permanent infrastructure, if risk factors and mitigation are considered in planning and construction.

Fig. 6: Sungai Kupang Debris Flow Geological Hazard Map (Source: JMG, 2022) (Destructive Zone - Red), (Hazard Zone - Yellow), (Safe Zone - Green)

- iii evacuation of residents from the Destroy Zone and Hazard Zone to a safe area. During these few months, the river water will remain murky, while flooding will be easier to happen due to shallow river conditions.

- iv river deepening and continuous cleaning of debris to reduce the risk of post-disaster flooding.
- v planting a deep rooting trees, shrubs, and ground cover plants in open areas to reduce the rate of erosion.

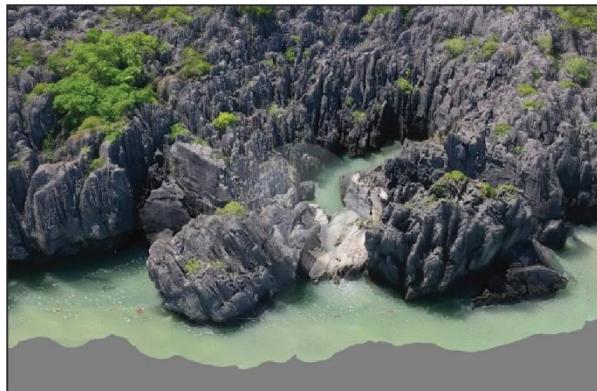
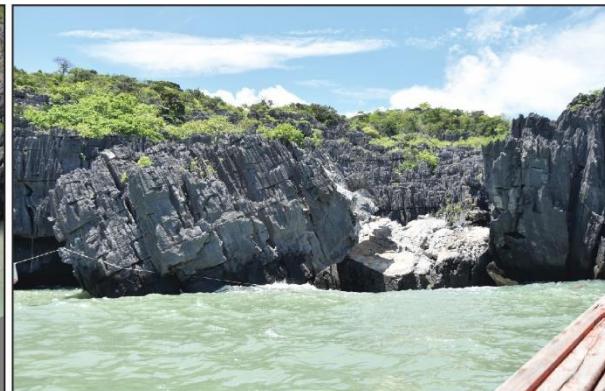
Fig. 1: The latest rockslide big event happened in the north part of the Prasat Hin Pan Yod chamber, Khao Yai Island on February 20, 2021

Based on the DMR field evidence, the rockslide occurrence may briefly conclude in four parts. First: erosion of fractured and cavernous limestone by sea, due to the location placing at the narrow strait of Khao Yai Island and the other island on the northern side, strong waves and rapid currents can enter cave passages to hit unstable rock columns that partly support cave roof, because of hydraulic power of the waves and compression of air within a confined space provide the fissures in rock mass widen and deepen and lead to having a broken column. Second: as a result of the supporting column is being broken, the loss of rock strengths cannot carry limestone overburden at the upper part. Third: the massive limestone volumes suddenly separated from the weakened sea cliff along major linear faults. Fourth: the upper part slides through rock mass sub-parallel bedding plane / along low angle fault and falls in the north direction into the sea, hiding the traditional entrance of the chamber. The fragment block of the rock-

Based on the orthophotos visual interpretation, geohazards in the Prasat Hin Pan Yod area have ever occurred at least 2 times: prior to the event on February 20, 2021, there was a precedent topple block sitting nearby the latest rockslide. A huge block of limestone was broken along a major joint/fault and fallen to sea by a toppling failure mechanism. Rockfall and rockslide in the Prasat Hin Pan Yod will happen in the near future.

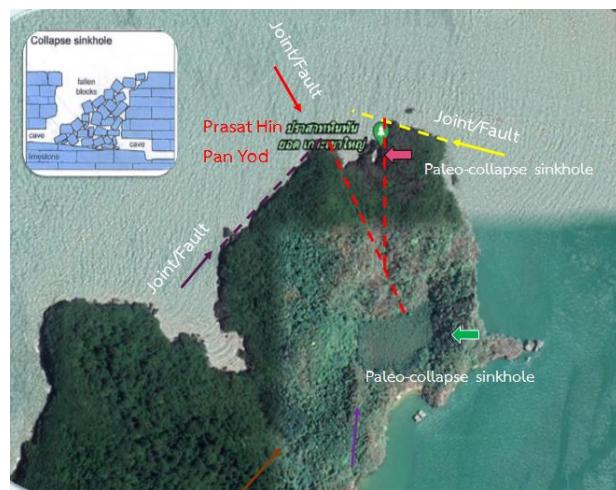
Fig.2: the Prasat Hin Pan Yod chamber showing oval shaped collapse sinkhole that occurred next to an older rectangular shape (Blue arrow)

-slide location is not far from the precedent rock topple. As mentioned above, the paleo-collapse sinkhole at the Prasat Hin Pan Yod can be a recurrence, particularly on the edge of the chamber.

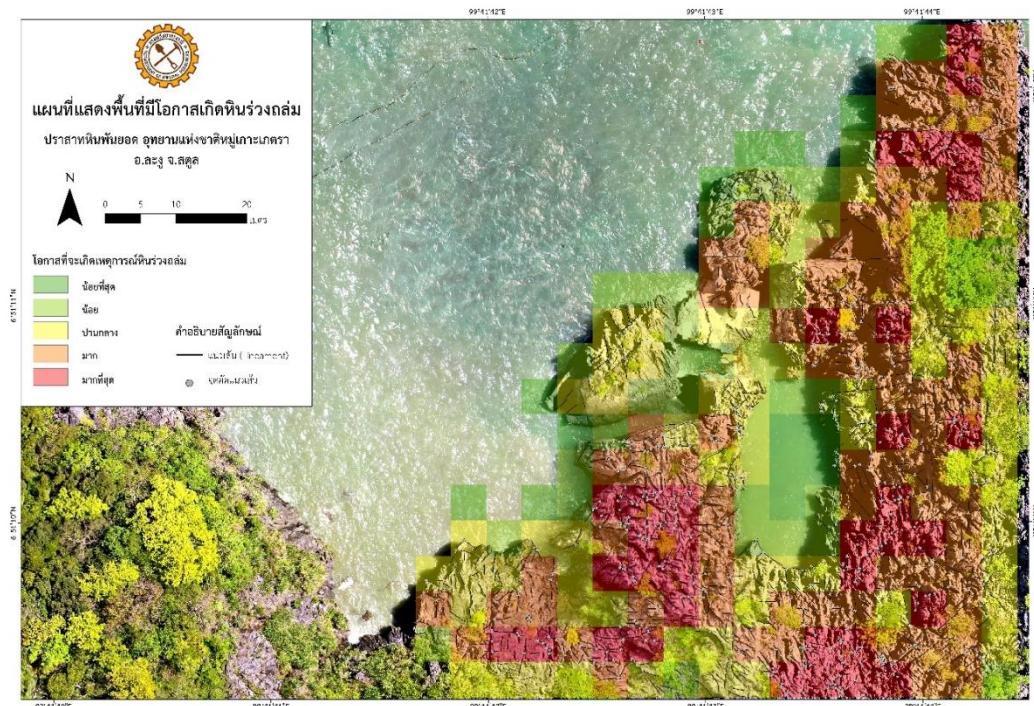
To examine the overview rock mass stability and select suitable locations for collecting field data, rockfall hazard zonation of the Prasat Hin Pan Yod chamber had mapped by using the approach of simple multi-criteria in GIS. The five basic factors were integrated to analyze and delineate rockfall hazard areas (Fig. 5). They are consisting of density of lines (Fig. 5A), density of intersection points (Fig. 5B), lineament proximity (Fig. 5C), slope (Fig. 5D), and aspect (Fig. 5E). The rockfall hazard zonation resulted in a grid cell size of 5x5 meters and was categorized into 5 classes including very low, low, moderate, high, and very high. The map shows moderate to high level hazard seems to be happening along sea cliffs and at the entrance of tourist sites as well (Fig. 6)

Fig. 6 preliminary rockfall hazard map, the Prasat Hin Pan Yod tourist site, Satun province.

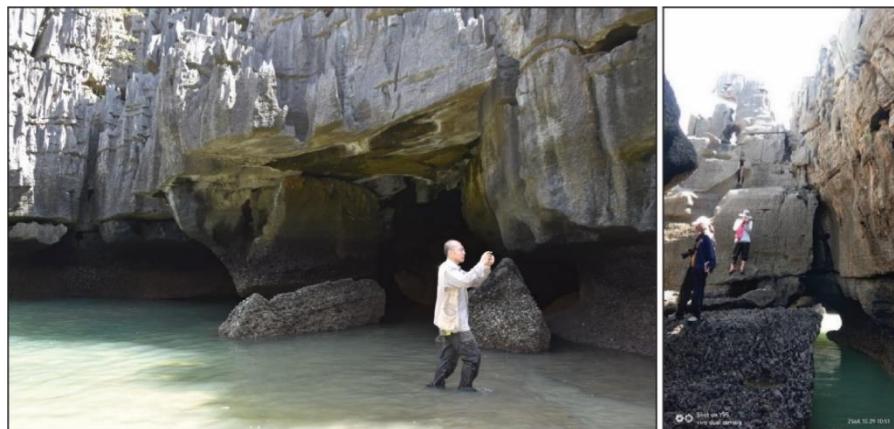
Station 2A (Fig. 13) is a place of the sea cave that locating beneath a massive limestone roof and supported by a thin column. The evidence of a former rockfall had two big blocks. Due to the high energy of currents and waves, rock collapse might have occurred in nearly future. The SMR value's wedge failure (Table 3 and 5) was categorized as bad and very bad. The SMR value was 8-18 and 25.5-33, respectively. Wedge failure of rockfall type has a higher potential to have occurred than planar and toppling failure. Moreover, bedding rockfall blocks is one of the high potential hazards, and it is difficult to determine by the SMR approach.

Fig. 13: photograph of station 2A (right) and station 4A (left)
