Initial Evaluation of Microstructure and Mechanical Properties of SA213 T22 Superheater Tube in a Bituminous Coal-Fired Power Plant

ABSTRACT

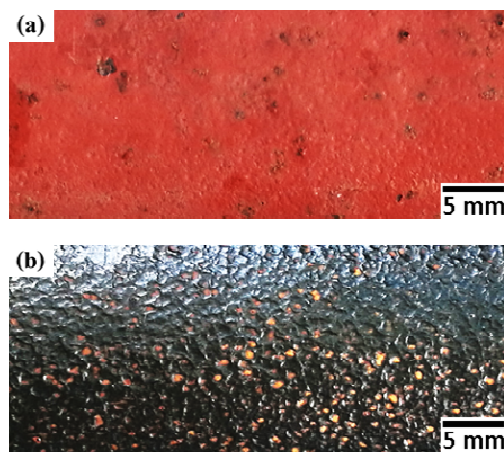
Figure 2 Exterior surface (a) unused tube; (b) used tube.

Visual inspection was performed to observe if the dimension of diameter or cracks would occur in the used steel tube. It was found that the diameter dimension showed no diameter dimension changes and no cracks taking place on the interior of the tube. The exterior conditions were then visually inspected and subsequently considered with that of the unused tube. It is clear that the exterior of the unused tube was smoother as compared to that of the used tube. Normally, during the operating period, the superheat tube experienced an elevated temperature atmosphere in the superheat zone of the boiler, which would be up to 500 °C. In addition, the burning of the bituminous coal can generate fly ash, which potentially results in ash deposition [3-4]. Both can cause the oxidizing environment, leading to the formation of oxide layer on the exterior of the used tube [5-6]. Nevertheless, this oxide layer was loose and discontinuous, leading to the disintegration into flakes and scales [4-5]. Thus, the rough surface of the outer can be attributed to the scale disintegration of the oxide formed in this severe environment [5-6]. The chemical composition of both tubes was analyzed and shown in Table 2. Besides, the chemical composition of SA213 T22 in the standard values is also given.

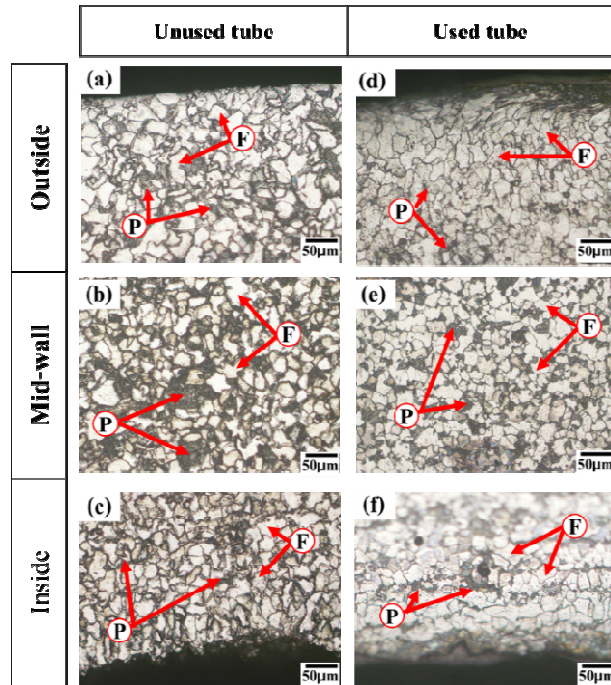
Samples of the used and unused steel tubes were prepared for microstructure examination. Fig.3 shows the micrograph of both tubes. It is obvious that both tubes consist of ferrite (white area) and nodular pearlitic (dark area), as indicated by arrows in

Fig.3. Besides, no microstructural changes in shapes or sizes of pearlite were observed from the used tube.

Figure 3 Optical micrographs of outer, mid-wall, and inner of the unused tube (a-c) and used tube (d-f).

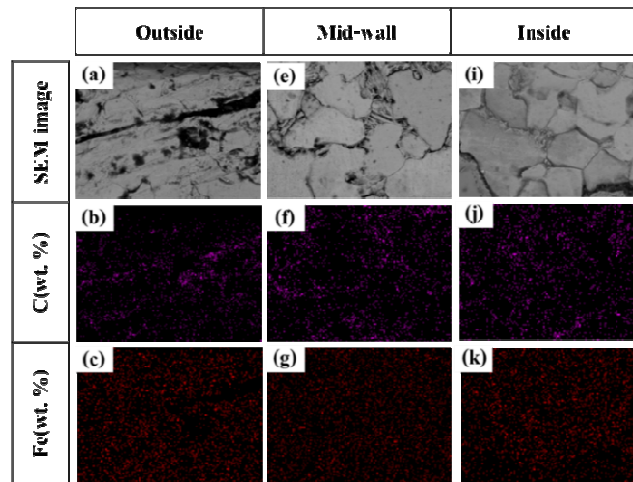
Figure 4 SEM micrograph and EDS examination of used steel tube (50X) of the exterior, mid-wall, and interior of the used tube: SEM image (a, e, and i); carbon distribution (b, f, and j); ferrous distribution (c, g, and k). The carbon (C) distribution is shown in purple and the ferrous (Fe) distribution in red, respectively

Fig. 4(a), (e) and (i) show SEM micrographs obtained from the exterior, mid-wall, and interior of the used steel tube from. From these micrographs, it was found that the pearlite morphology did not present any significant changes. No pearlite disintegration was found in the initial exposure in the superheat environment. Carbon and ferrous distribution at the outer, mid-wall, and inner of the utilized steel tube are given in Figs. 4(b) and (c), Figs. 4(f) and (g), and Figs. 4(j) and (k), respectively. Obviously, ferrous was uniformly distributed all over the matrix of the whole monitored regions and the carbon dispersion means the presence of carbon accumulation in pearlite.

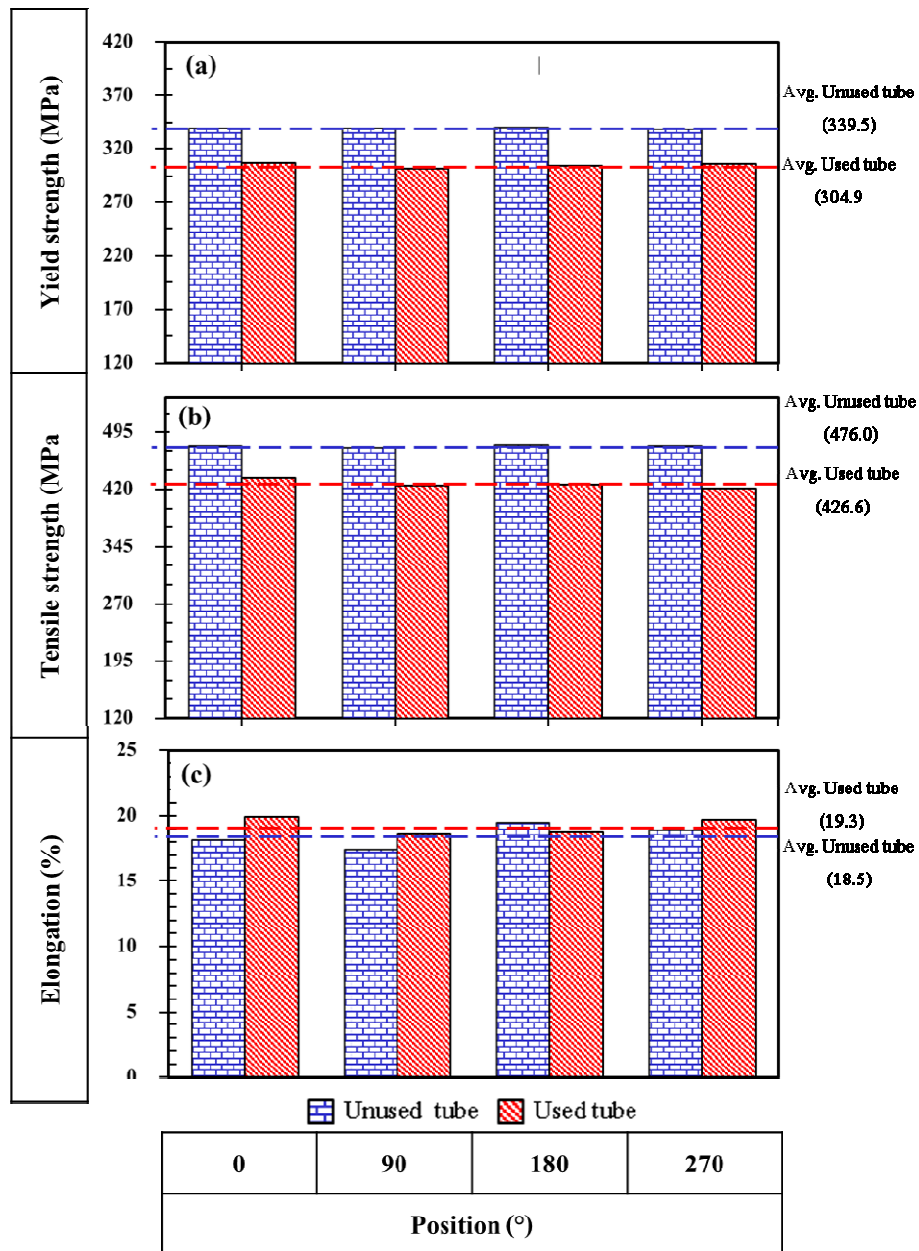
Fig. 5 shows tensile test results of new and used tubes. Evidently, tensile strength and yield strength values of the used steel tube were lower in contrast to those from the unused tube. However, the used tube exhibited higher elongation values as compared to those of the unused tube.

Technically, during the operating period, the used tube experienced the high temperature environment (500 °C or above 500 °C) [12,13]. In addition, ash deposition can occur due to the combustion of bituminous coal. In this condition, oxidizing environment can occur, resulting in the scale disintegration of the oxide layers formed in the used tube, known as “Thermal oxidation” [13-15]. In addition to this degradation, the chemical composition in Table 1 shows the decreased carbon content in the used steel tube. Normally, the decreased carbon content in steel probably means the decarburization, resulting in the significant reduction in the strength and hardness of materials. Furthermore, decarburization requires carbon diffusion [13,16]. This can cause the formation of the decarburized zone, which facilitates the phase transformations [14]. The recovery process or grain growth process may occur and would result in increased ductility, but lower strength. Thus, decarburization and high temperature oxidation were responsible for the decreased strength and hardness and increased elongation of the used steel tube in the superheat zone.

Figure 5 Tensile test results of unused and used tube (a) Yield strength, (b) Tensile strength; (c) Elongation.

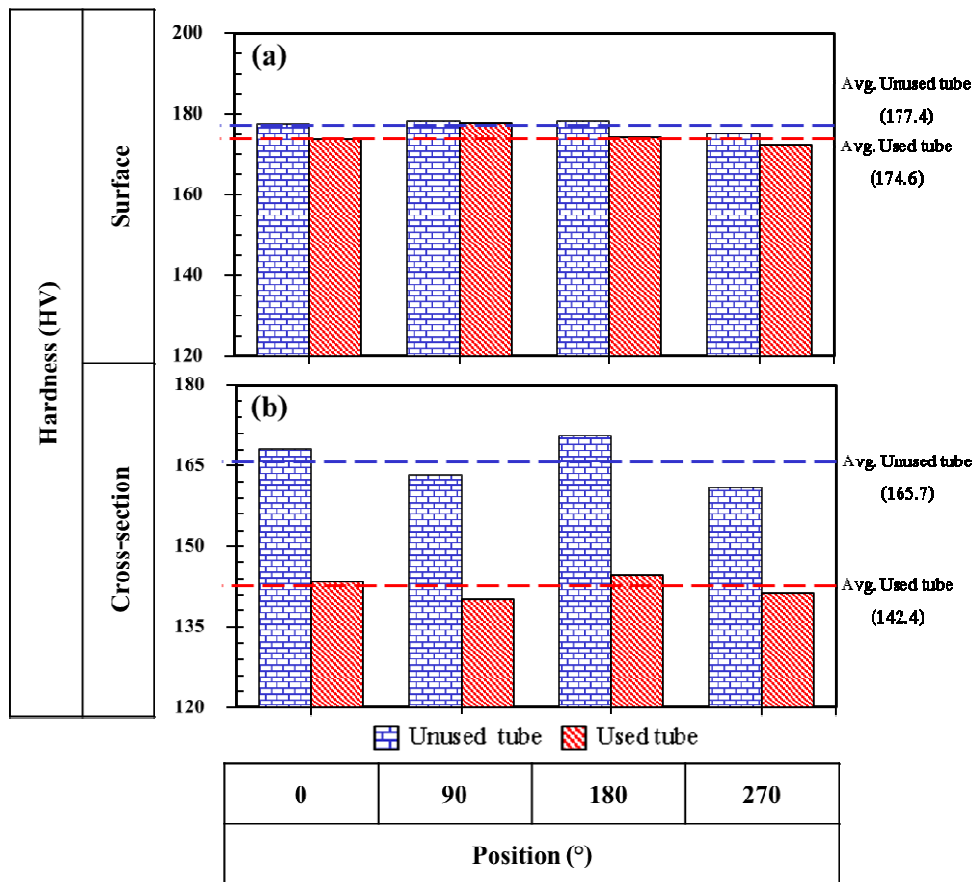
The hardness test results of unused and used tubes are shown in Fig. 6. It was obvious that the hardness values of the used tube were smaller than those of the new tube. Normally, strength of material can be indicated by both yield and tensile strength, whereas ductility can be specified by elongation [6-7,11]. In this monitoring, the used tube showed the lower values in tensile and yield strength in all measured positions.

Figure 6 The hardness test results of unused and used tube (a) surface; (b) Cross-section.
