# Rock Failure Assessment on Paleo-Collapse in Case of the Prasat Hin Pan Yod tourist site, Satun Geopark, Thailand

*Environmental Geology Division, Department of Mineral Resources (DMR), Bangkok, Thailand*

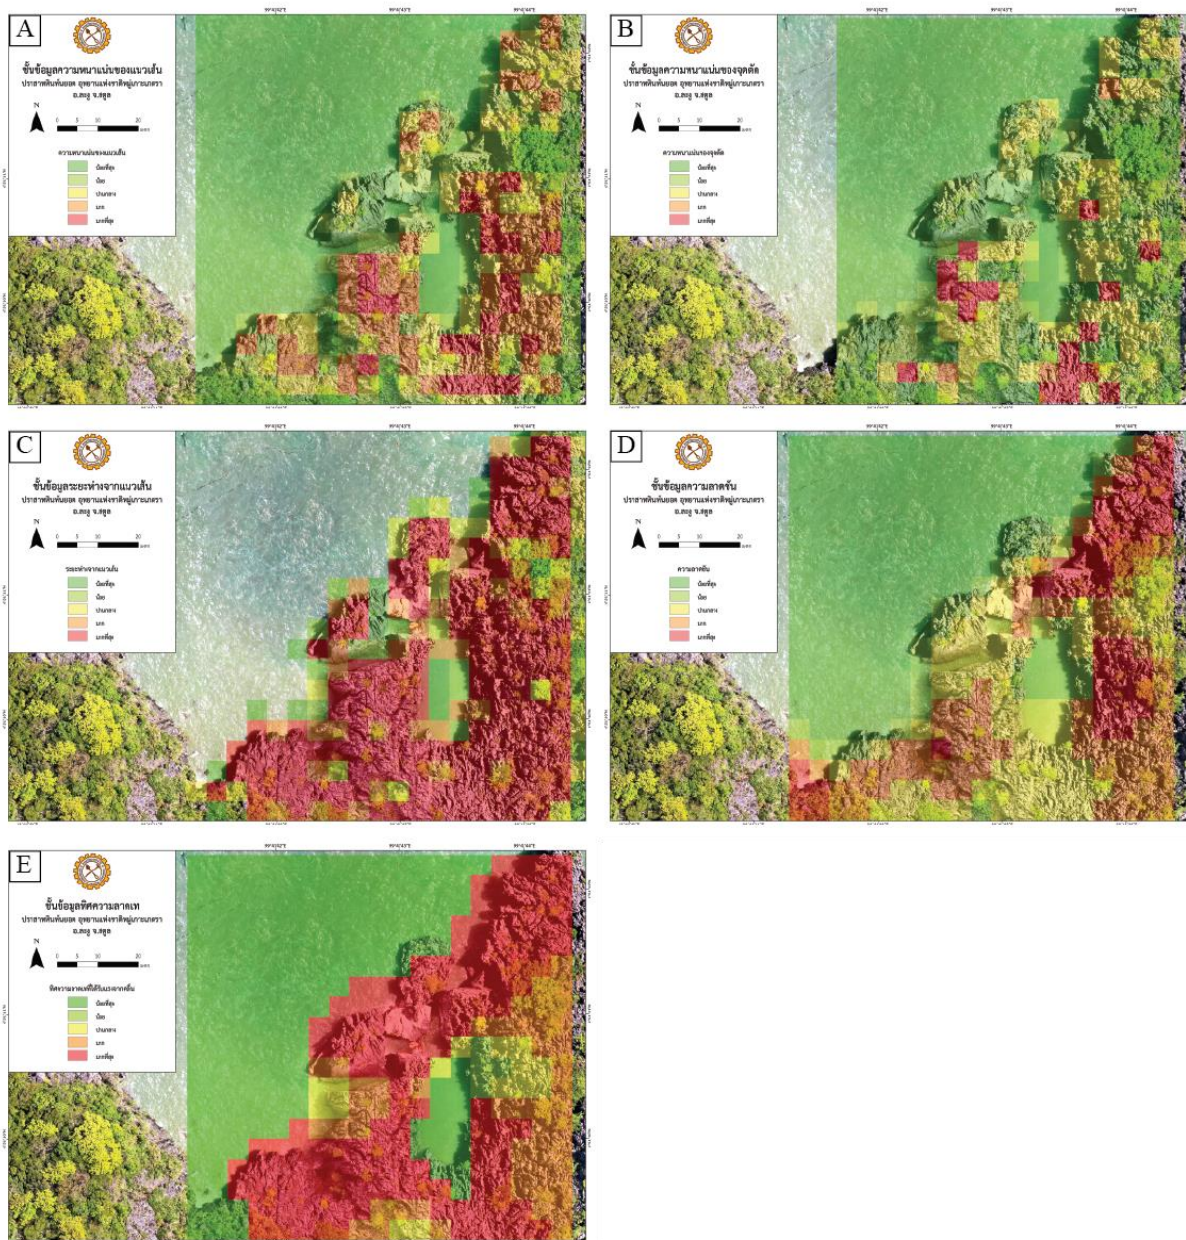
Fig.5 Five factors for preliminary rockfall hazard mapping using GIS; (A) density of lines, (B) density of intersection points, (C) Lineament proximity, (D) slope, and (E) aspect.

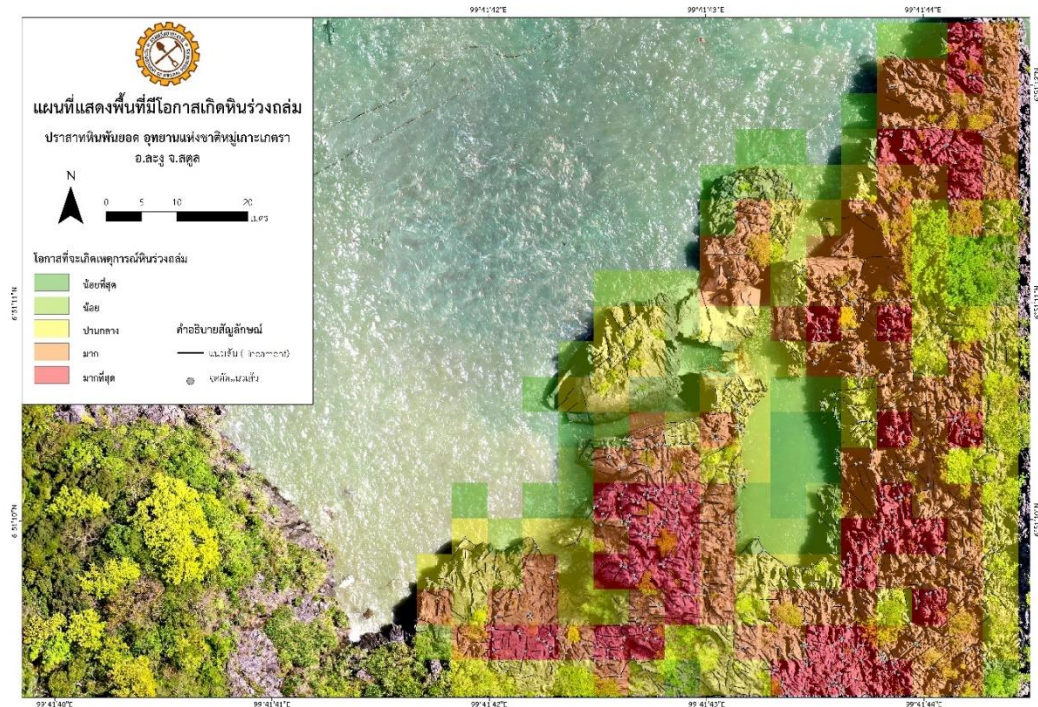
To examine the overview rock mass stability and select suitable locations for collecting field data, rockfall hazard zonation of the Prasat Hin Pan Yod chamber had mapped by using the approach of simple multi-criteria in GIS. The five basic factors were integrated to analyze and delineate rockfall hazard areas (Fig. 5). They are consisting of density of lines (Fig. 5A), density of intersection points (Fig. 5B), lineament proximity (Fig. 5C), slope (Fig. 5D), and aspect (Fig. 5E). The rockfall hazard zonation resulted in a grid cell size of 5x5 meters and was categorized into 5 classes including very low, low, moderate, high, and very high. The map shows moderate to high level hazard seems to be happening along sea cliffs and at the entrance of tourist sites as well (Fig. 6)

Fig. 6 preliminary rockfall hazard map, the Prasat Hin Pan Yod tourist site, Satun province.

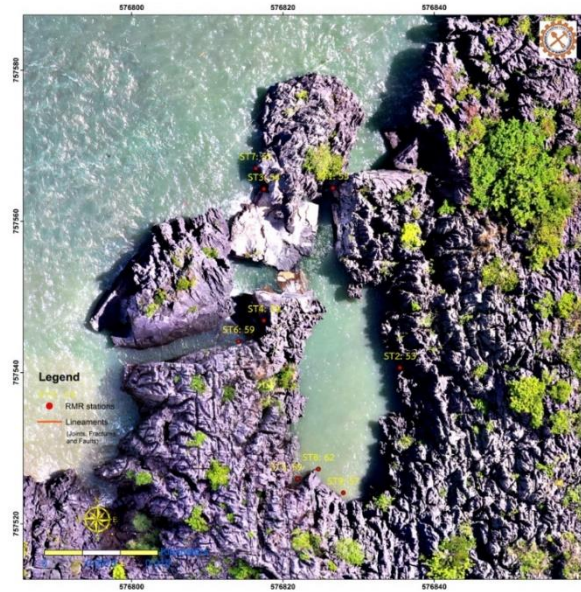
The RMR is a geomechanics classification system for rock mass. A sum of each rating values provide overall comprehensive index of rock mass quality or RMR value (Bieniawski, 1989). The RMR values can be estimated through 9 locations (Fig. 7) distributed along the rim of the chamber, a big broken block of limestone, and the new expected entrance of the tourist site. The RMR values ranged from 53 to 62 (Table 1). The result shows that the RMR of the bedded limestone has lower values than the massive limestone. Thinner bedding is stratigraphically overlying on the Massive limestone, so it is hard to explore the unstable rock when the rock mass locates in the high places of the Prasat Hin Pan Yod area.

Fig. 7 showing stations of measured Rock Mass Rating overlying on orthophoto

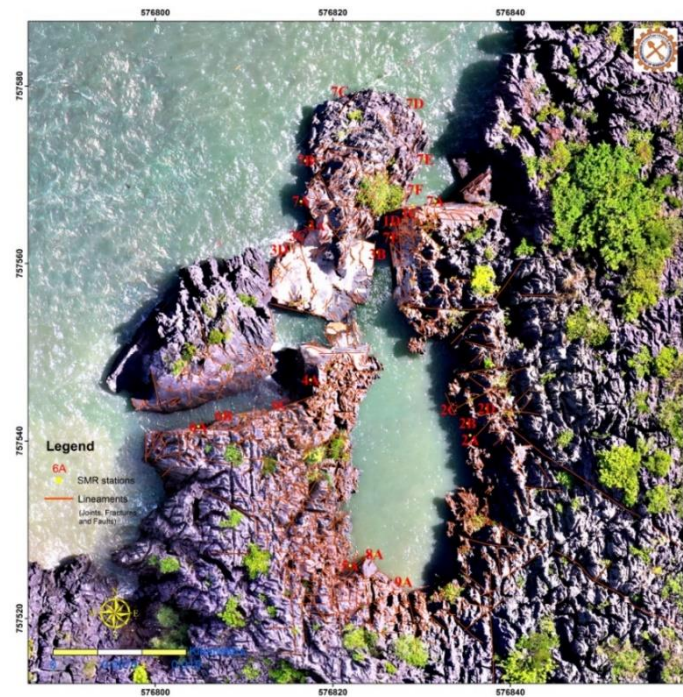
The SMR was developed by Romana (1985) for evaluating rock slope stability. The SMR assessment in the Prasat Hin Pan Yod area can be divided into 4 sub-areas with totally 26 of SMR stations (Fig. 12).

- 1) The area of rockslide on February 20, 2021 that nowadays hiding the Prasat Hin Pan Yod entrance, in which was represented by the stations of 1A to 1E, 3A to 3D, and 7A to 7F.
- 2) The strait locating between linearly sea cliff and the former huge topple of rock mass, in which was illustrated by the stations of 4A, and 6A to 6C.
- 3) A high eroded sea cave with clues of former rockfall and thin column supporting with high potential hazard, which representative stations was composed of 2A to 2C.

**Fig. 12:** showing stations of Slope Mass Rating (SMR) assessment

4) A small beach within the Prasat Hin Pan Yod chamber that exposed whenever low tide, the representative stations were 8A and 9A.

(SW) may be originated from wedge failure of rockfall type. As mentioned, the tourist route for the inner chamber should not pass stations 1A, 1C, and 1E.
