THAI GEOSCIENCE JOURNAL

Vol. 4 No. 6 July 2023

Rock Failure Assessment on Paleo-Collapse in Case of the Prasat Hin Pan Yod tourist site, Satun Geopark, Thailand

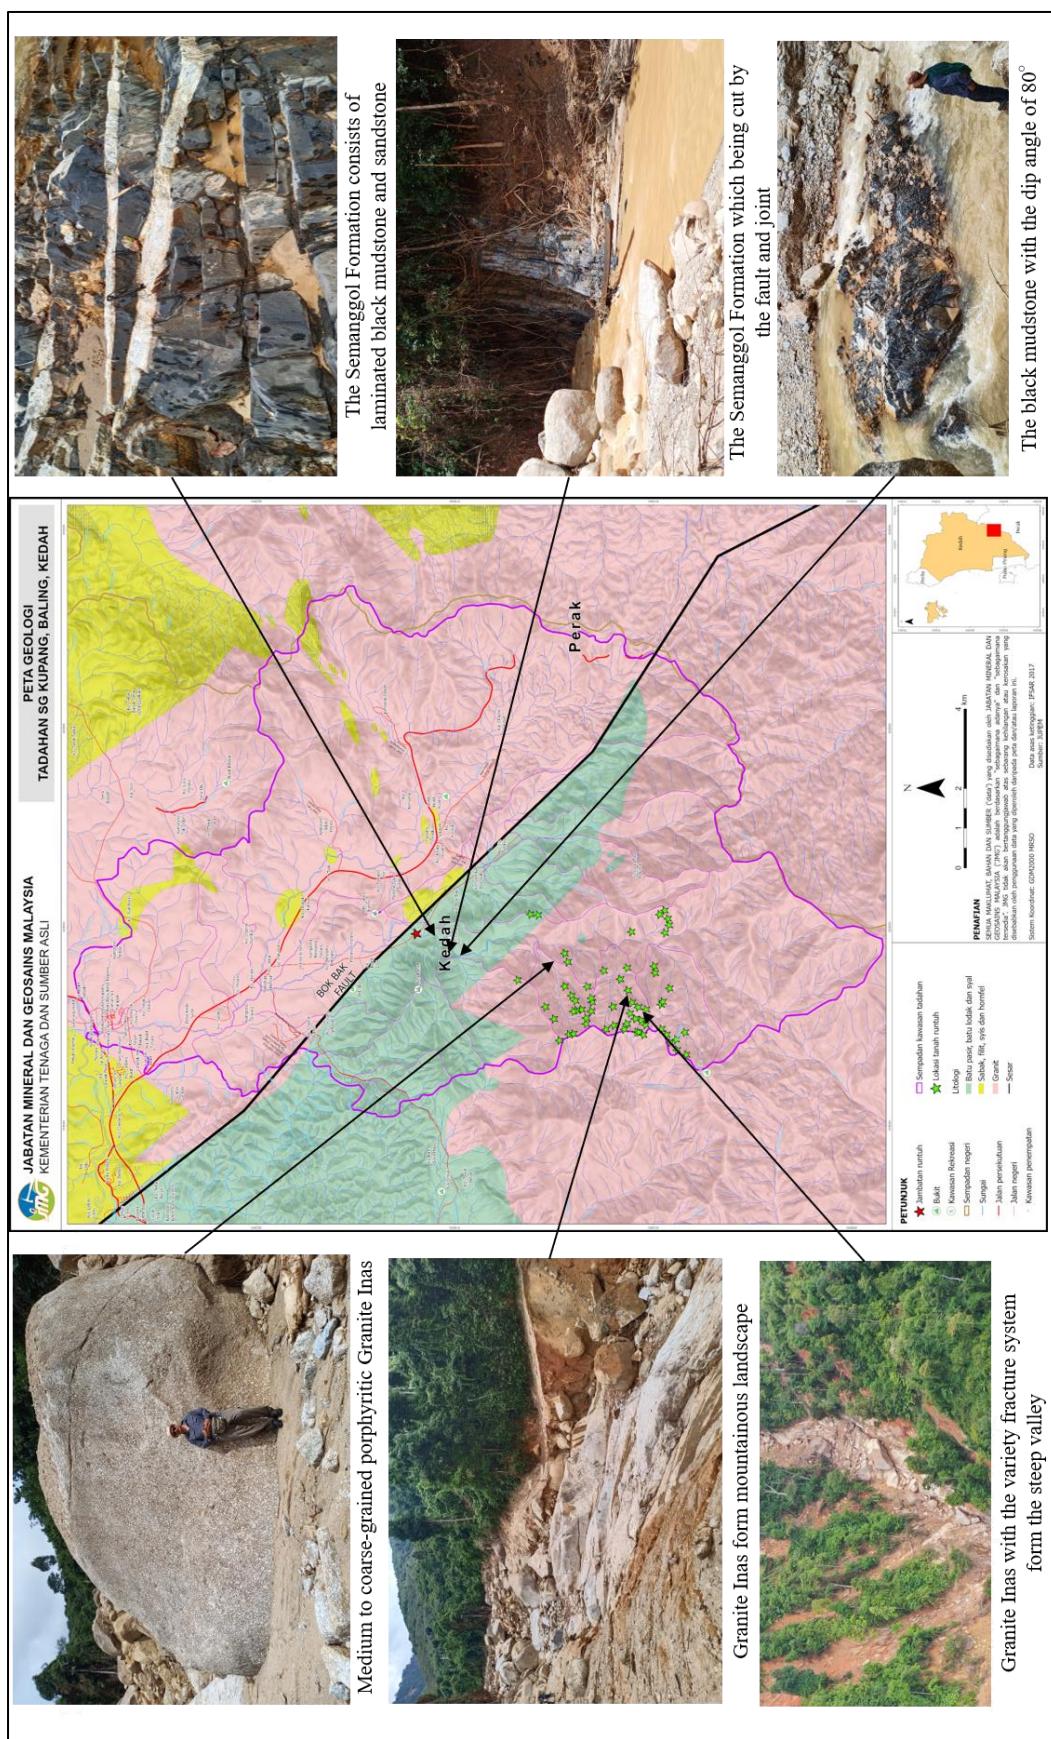
The entire Sungai Kupang Basin is underlain by three main rock units, namely Inas Granite in the upstream part of the basin with high topography (ranging from 200 m to more than 1450 m), Semanggol Formation in the middle and Kroh Formation which forms the low and undulating hills at the very downstream (Fig. 2). The Inas Granite in the upstream covers almost 70% of the rock distribution in the Sungai Kupang Basin area. The granite consists of medium- to coarse-grained porphyritic granite formed by quartz, feldspar and biotite minerals. The Semanggol Formation, which consists of laminated black mudstone and sandstone, forms the lowland that underlies almost 25% of the Sungai Kupang Basin area. This formation is separated from the granite by a major fault known as Bok Bak Fault. This fault has formed a clear topographic or slope change from steep in the granite area to very gentle land in Semanggol Formation. The

Fig 2: The Geology Map of the Sungai Kupang Basin (Source: JMG, 2022)

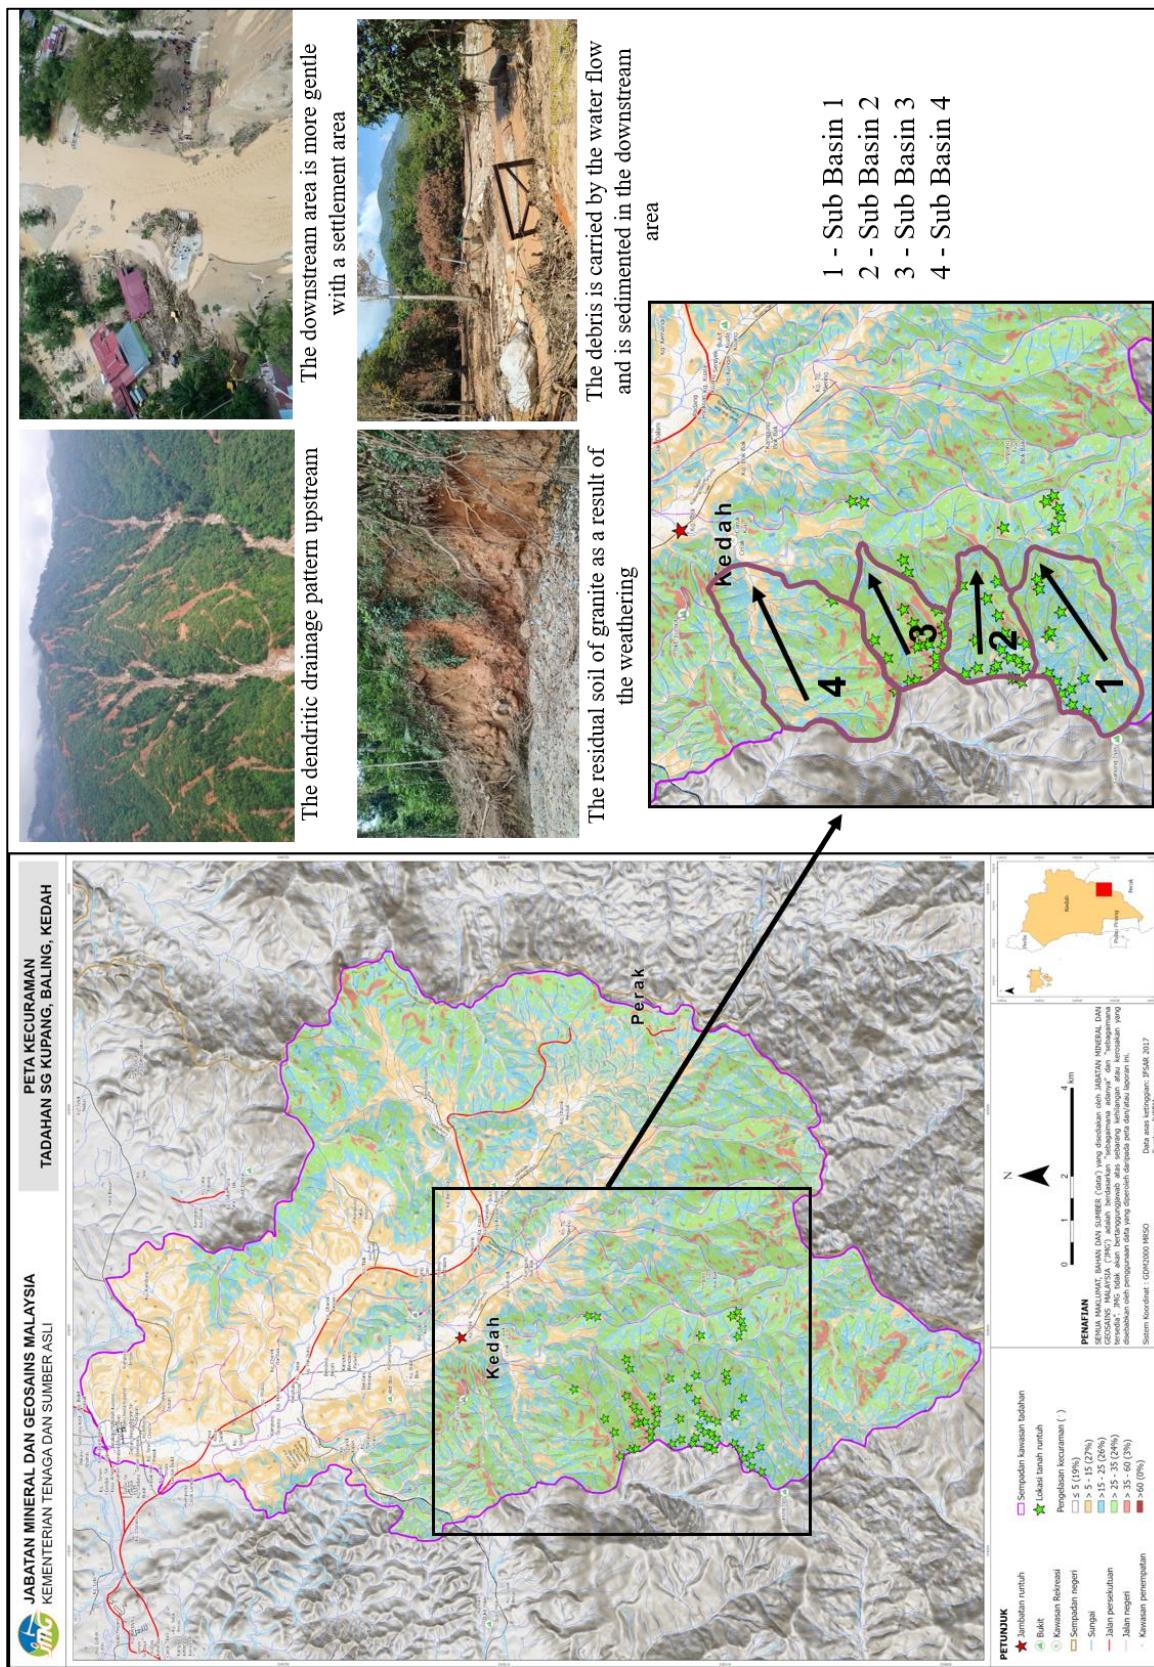
upstream to low-lying area are controlled by the underlying rock and lithological units. Between the peaks and the lowlands, there are river channel with V-shaped that became the transport zones of debris. The dendritic drainage pattern upstream form four (4) sub-basins that eventually merge with the main river forming the Sungai Kupang Basin (Fig. 3).

Fig. 3: The Geomorphology Map of the Sungai Kupang Basin (Source: JMG, 2022)

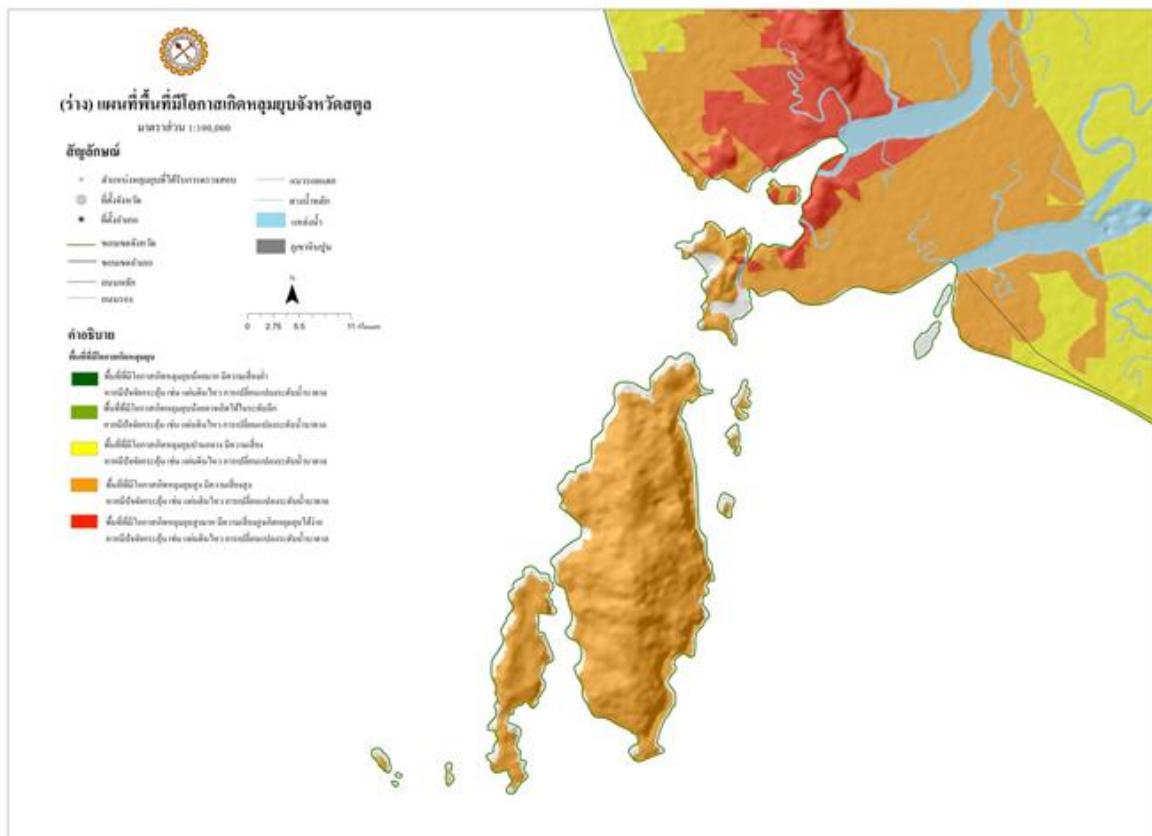
**Fig.4:** High sinkhole potential covering the Prasat Hin Pan Yod chamber (Black dash rectangular shape) and the overall area of Koh Kao Yai Islands

low, medium, high, and very high. The grid cell resolution of the map is 30x30 meters. The high potential area is abundantly covered in the Koh Kao Yai Islands, particularly in the Prasat Hin Pan Yod chamber (Fig. 4). Types of the sinkholes as classified by Waltham et al. (2005) do not conduct by the DMR due to the scarcity of fundamental analysis data. However, an enhanced sinkhole potential map is still useful for limestone failure assessment in the Prasat Hin Pan Yod area.

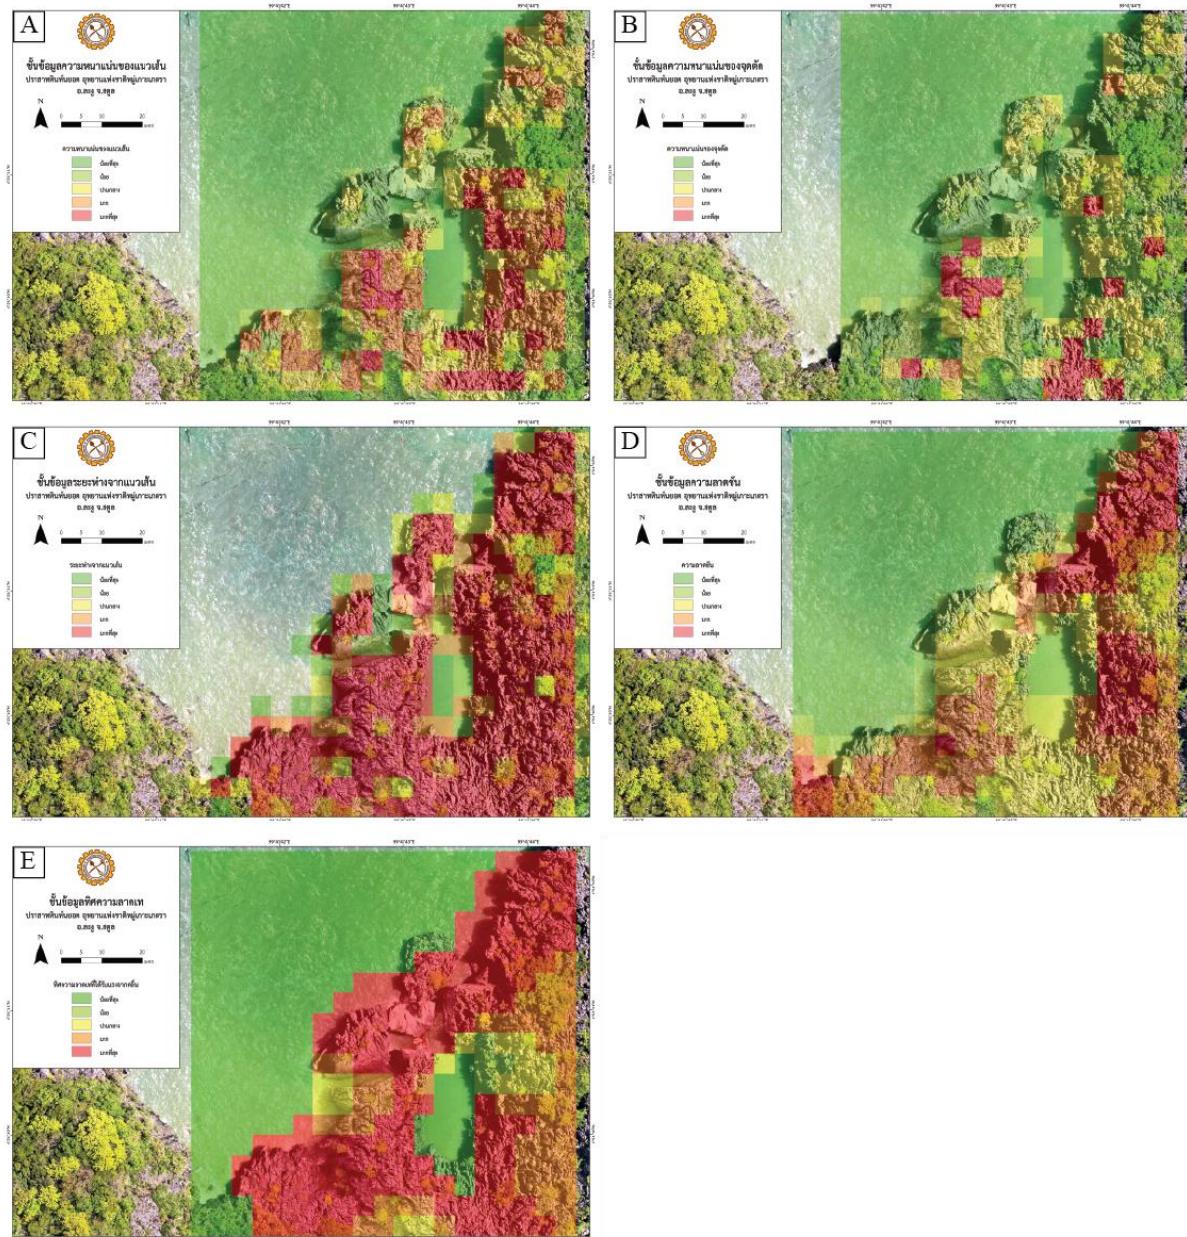
To examine the overview rock mass stability and select suitable locations for collecting field data, rockfall hazard zonation of the Prasat Hin Pan Yod chamber had mapped by using the approach of simple multi-criteria in GIS. The five basic factors were integrated to analyze and delineate rockfall hazard areas (Fig. 5). They are consisting of density of lines (Fig. 5A), density of intersection points (Fig. 5B), lineament proximity (Fig. 5C), slope (Fig. 5D), and aspect (Fig. 5E). The rockfall hazard zonation resulted in a grid cell size of 5x5 meters and was categorized into 5 classes including very low, low, moderate, high, and very high. The map shows moderate to high level hazard seems to be happening along sea cliffs and at the entrance of tourist sites as well (Fig. 6)

Fig.5 Five factors for preliminary rockfall hazard mapping using GIS; (A) density of lines, (B) density of intersection points, (C) Lineament proximity, (D) slope, and (E) aspect.

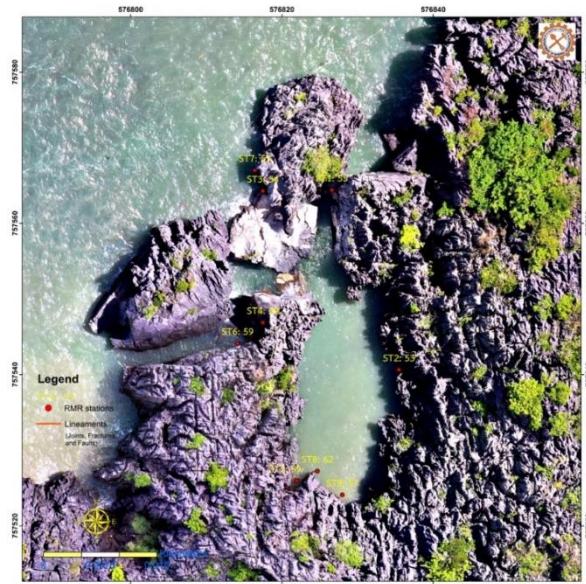
The RMR is a geomechanics classification system for rock mass. A sum of each rating values provide overall comprehensive index of rock mass quality or RMR value (Bieniawski, 1989). The RMR values can be estimated through 9 locations (Fig. 7) distributed along the rim of the chamber, a big broken block of limestone, and the new expected entrance of the tourist site. The RMR values ranged from 53 to 62 (Table 1). The result shows that the RMR of the bedded limestone has lower values than the massive limestone. Thinner bedding is stratigraphically overlying on the Massive limestone, so it is hard to explore the unstable rock when the rock mass locates in the high places of the Prasat Hin Pan Yod area.

Fig. 7 showing stations of measured Rock Mass Rating overlying on orthophoto

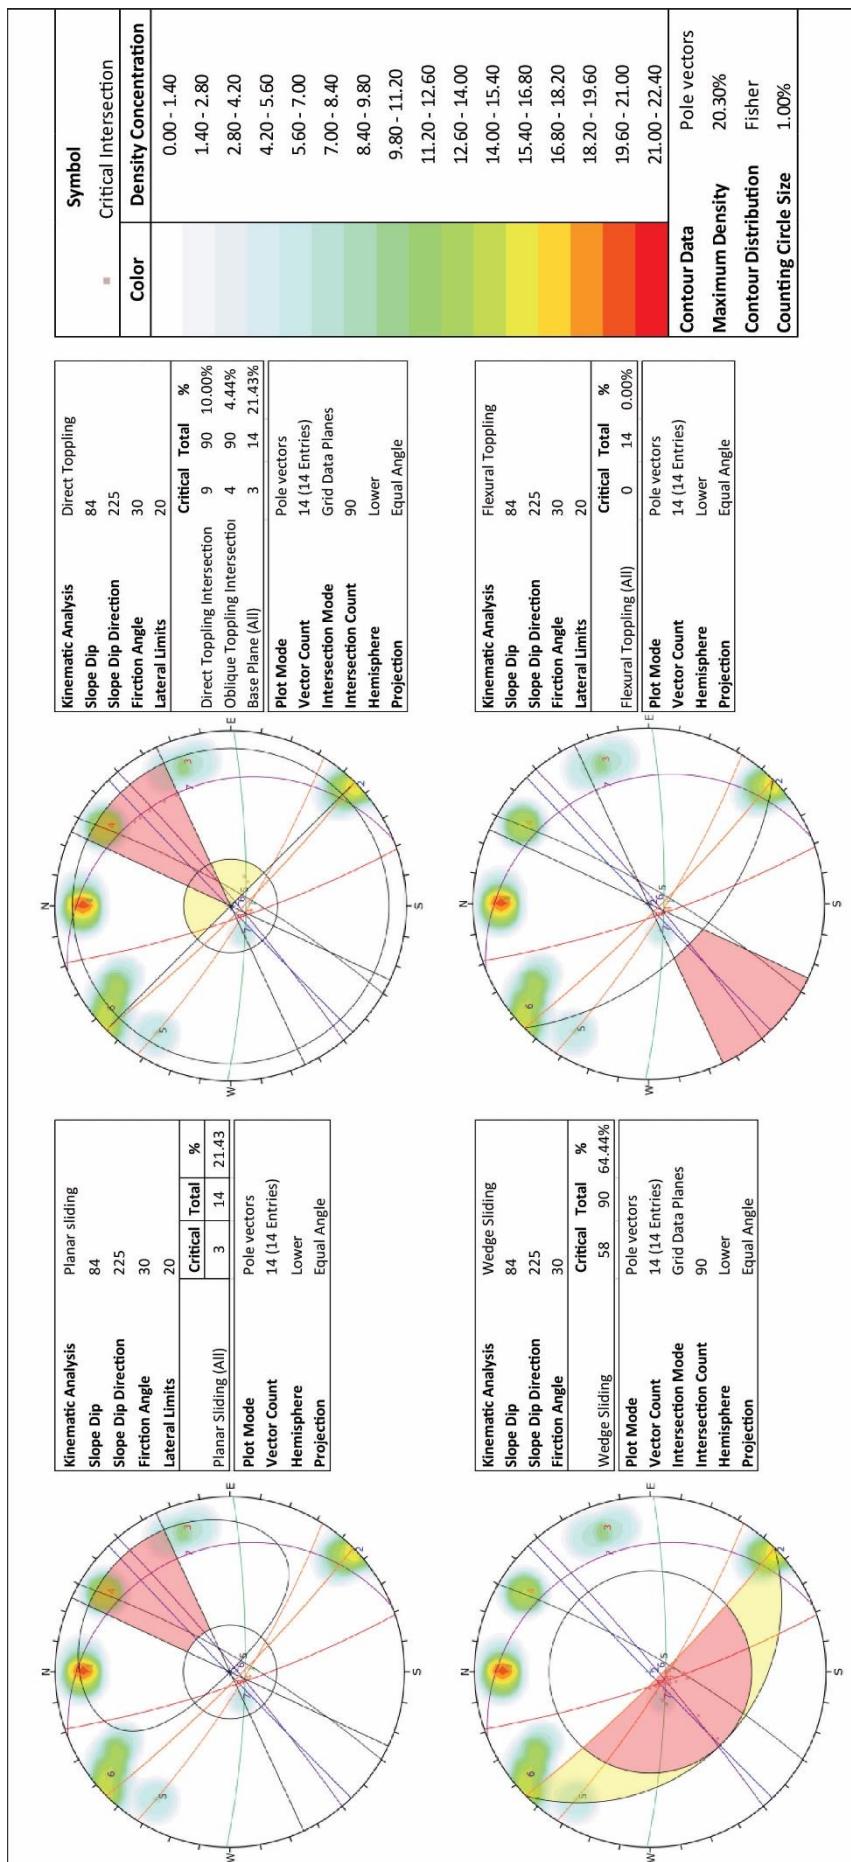
The making of stereographic projection from the discontinuous planes on the outcrop slope was used for modeling rock mass failures or rockfall types that can occur in a planar, wedge, or toppling. The rock mass failures were next used to calculate the SMR adjustment factors. Some stations are selected to show as samples of the stereographic projection analysis which shown below (Figs 8, 9, 10 and 11).

Fig. 8: showing stereographic projection of the station 2C

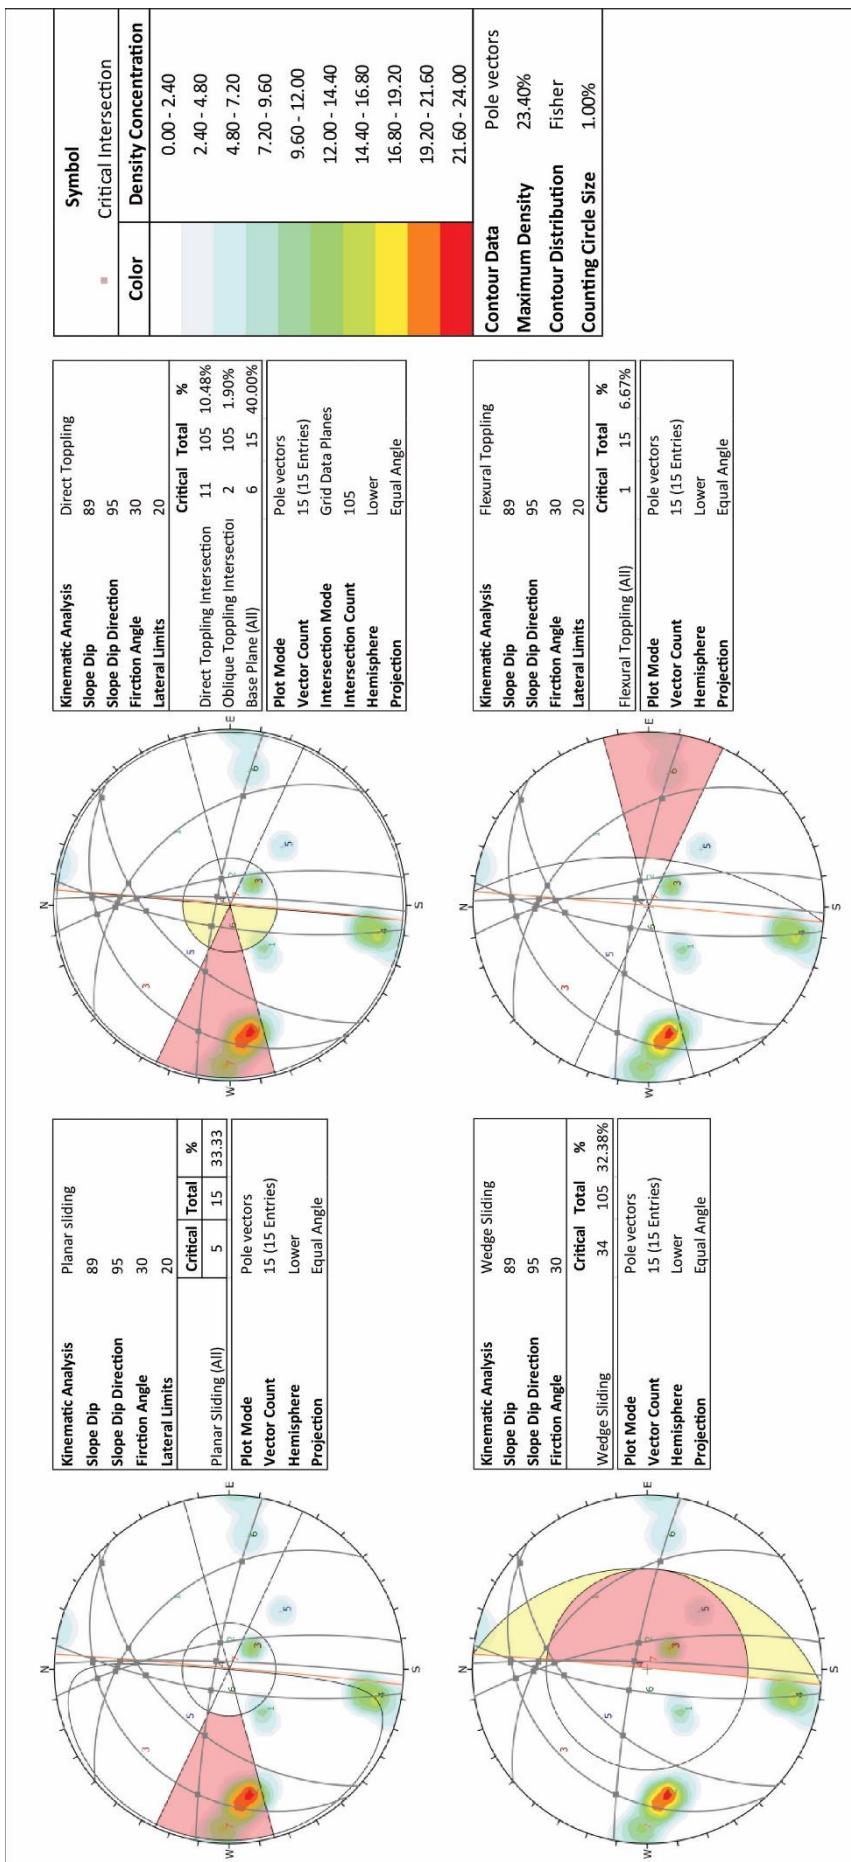
Fig.9: showing stereographic projection of the station 3B

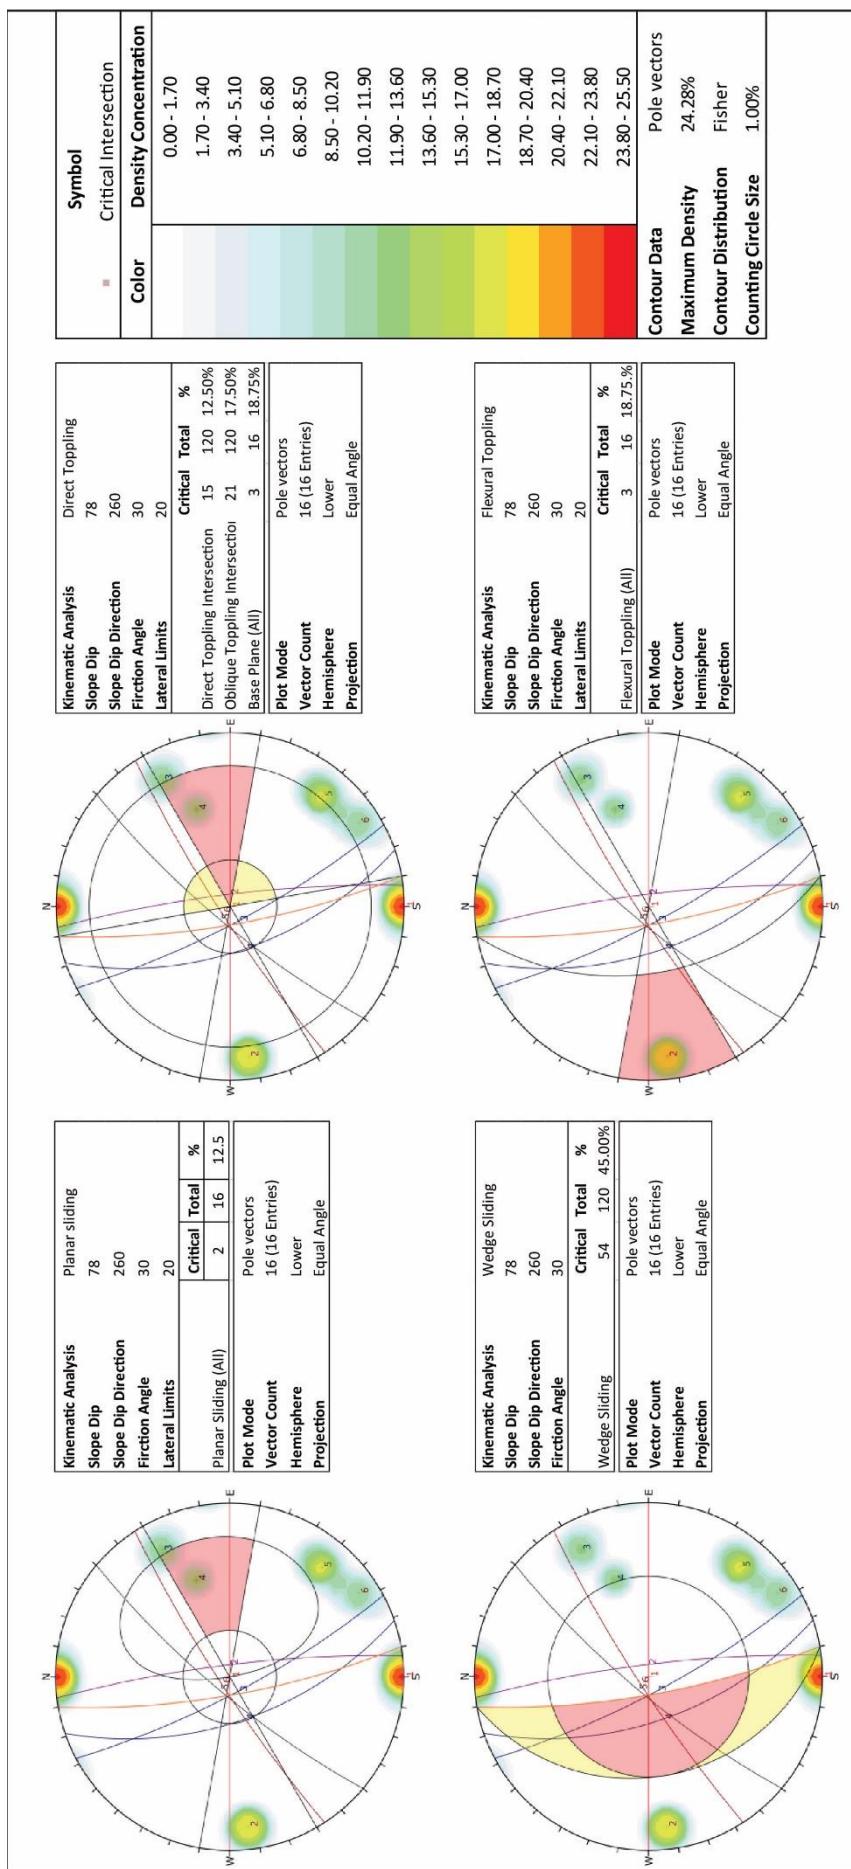
Fig. 10: showing stereographic projection of the station 4A

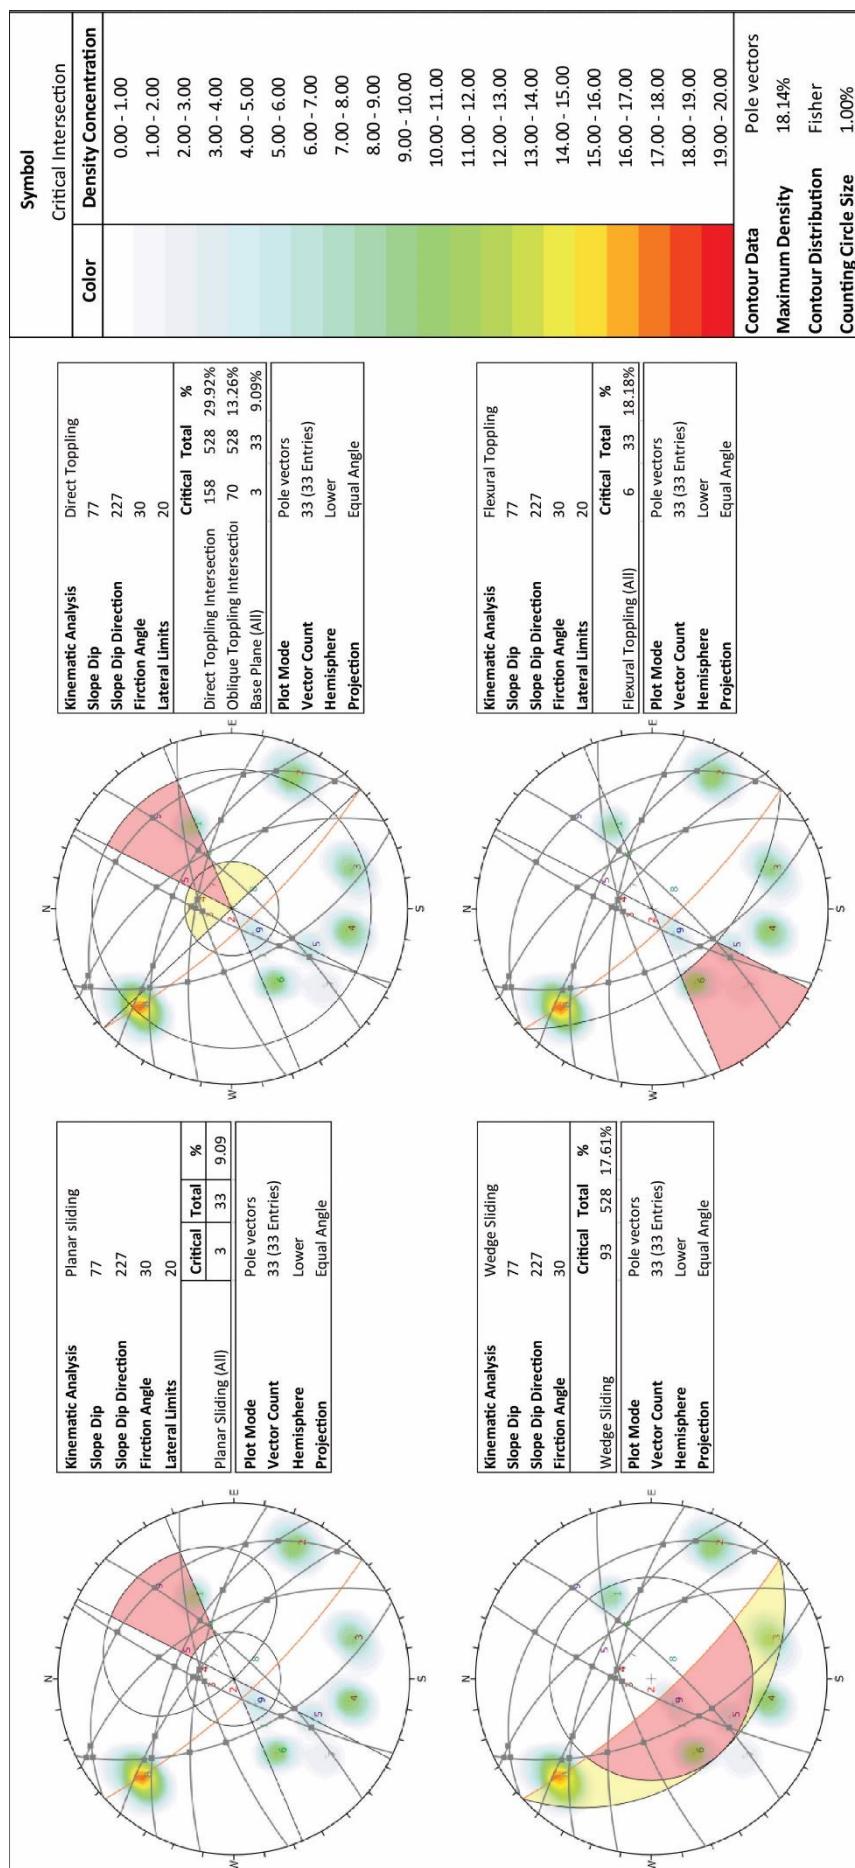
Fig. 11: showing stereographic projection of the station 7D

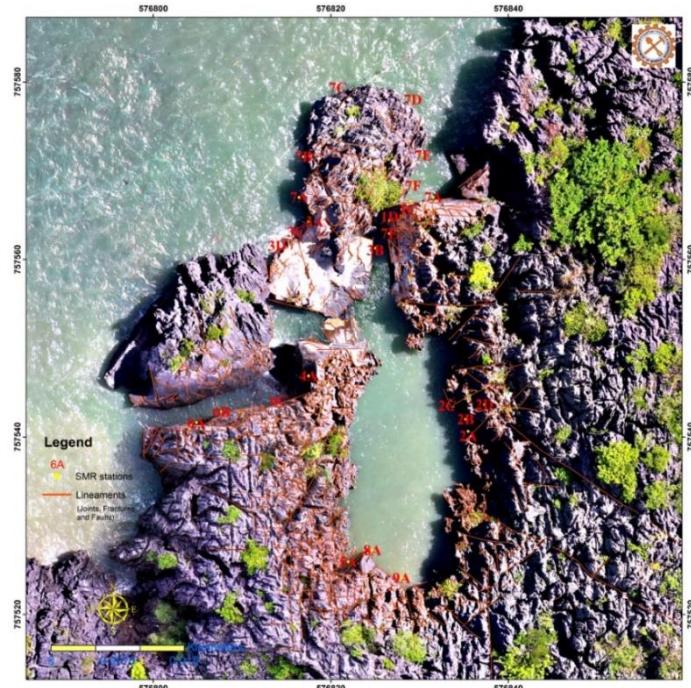
The SMR was developed by Romana (1985) for evaluating rock slope stability. The SMR assessment in the Prasat Hin Pan Yod area can be divided into 4 sub-areas with totally 26 of SMR stations (Fig. 12).

- 1) The area of rockslide on February 20, 2021 that nowadays hiding the Prasat Hin Pan Yod entrance, in which was represented by the stations of 1A to 1E, 3A to 3D, and 7A to 7F.
- 2) The strait locating between linearly sea cliff and the former huge topple of rock mass, in which was illustrated by the stations of 4A, and 6A to 6C.
- 3) A high eroded sea cave with clues of former rockfall and thin column supporting with high potential hazard, which representative stations was composed of 2A to 2C.

Fig. 12: showing stations of Slope Mass Rating (SMR) assessment

4) A small beach within the Prasat Hin Pan Yod chamber that exposed whenever low tide, the representative stations were 8A and 9A.
